Berlin Middle School

Building Overview:

Existing Condition Assessment:

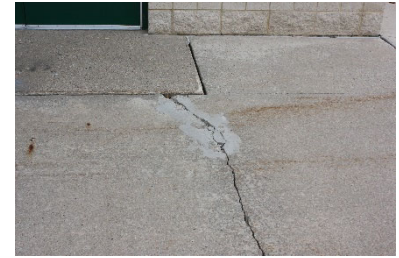
Figure Ext. 1

Concrete walks: An observed condition is the patches installed as corrective action, where concrete has spalled near the edges of a control or construction joint (Figure Ext.1). These repairs, although unsightly, are to ensure that pedestrian traffic does not trip on the pothole created at the spalling.

- Exit Doors: No recommendations currently.
- Windows General Conditions: No recommendations currently.
- Stone and masonry sills: No recommendations currently.
- Roofing: No recommendations currently.
- Roofing Accessories: No recommendations currently.
- Control Joints: No recommendations currently.
- Walls: No recommendations currently.
- Paving and lots: Consider concrete replacement at the severely rust-stained stoops. Using a concrete additive and coated reinforcement can prevent rust staining. Consider replacing the concrete walks and curbs that are deteriorated and patched. Include the sections of concrete that are uneven and ones that need to be ground down.

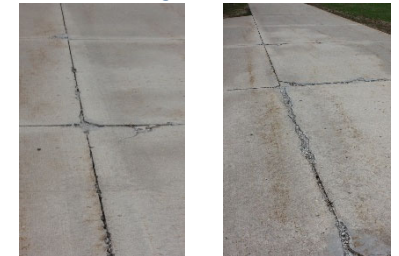
Figure Ext. 2

Where the patching has not been installed, the concrete edges are gradually spalling and eroding (Figure Ext.2). This might be slowed down by sealing the concrete to protect this particular concrete mixture from the salt.

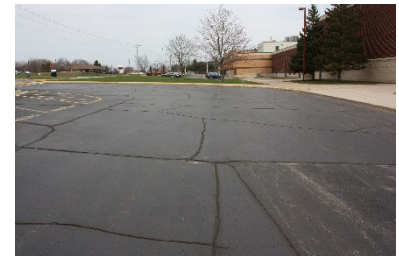
Figure Ext. 3

- Asphalt Paving: The asphalt paving is in generally fair condition. The cracks have been filled to prevent water from getting into the substrate. Some areas have tighter knit cracks that need to be monitored.

Continue filling the cracks in the asphalt to keep water from infiltrating the subgrade. Monitor the cracking after every winter to verify the asphalt doesn't crack into small pieces or create potholes.

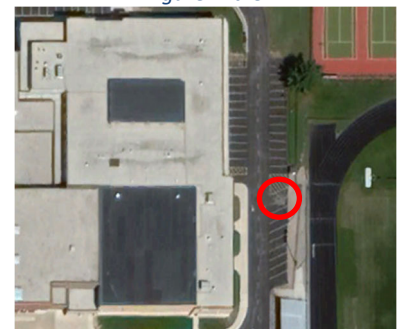
Figure Ext. 4

Maintenance may be deferred in most areas; however, one location is reported to have a potential issue. Figure Ext.4 shows the approximate location where a catch basin may be compromised, and the underground erosion is occurring. This could mean a storm pipe may be compromised and the catch basin leaking into the soil, washing soil into the storm system. This is causing the asphalt to sink around the immediate area of the catch basin (Figure Ext.5).

- Stormwater catch basin: Investigate the potential undermining at the two indicated catch basin locations. Repair these conditions to prevent dangerous sinkhole conditions.

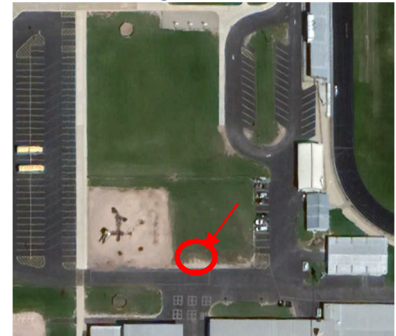
Figure Ext. 9

At the bike rack, there is an area with river stones in the landscaping. This is adjacent to a drainage path to a storm inlet; however, this area is too low and ponds water. The ponding is depositing sediment and causing an unsightly condition directly adjacent to the public entrance.

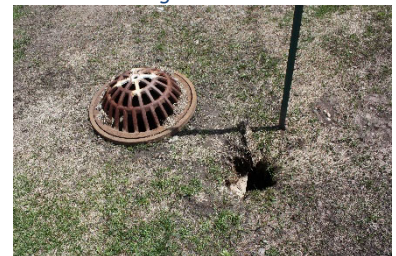
Figure Ext. 10

South of the building near the maintenance access drive is another catch basin in the grass that may have a compromised basin and pipe connection. The soil here is also getting undermined, and a sinkhole is beginning to form. This is causing a dangerous condition at the edge of the catch basin/yard drain (Figure Ext.10).

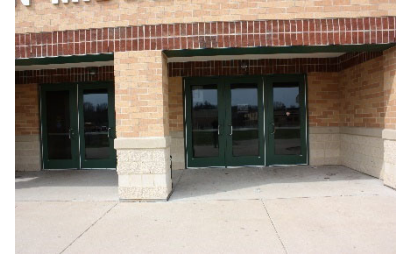
Figure Ext. 11

There is a door panel that has had a glazing unit replaced as it was taped up for glazing sealant curing.

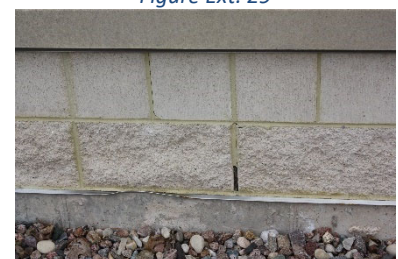
Figure Ext. 30

There are some locations where the flashing drip edge is bent. This may have happened during backfilling procedures. This may not have any negative effects, but it could be mechanically straightened out.

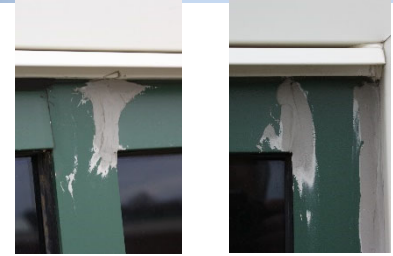
Figure Ext. 44

- Roof Drainage Components: At the clear stories, sealant has been added to the window frames to mitigate apparent window leaks (Figure Ext.44).

It is recommended to investigate this issue further to verify the issue behind this condition.

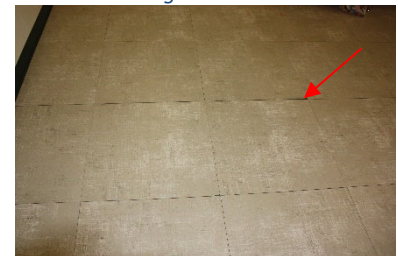
Figure Int. 4

There is also LVT (Luxury Vinyl Tile) in some locations (Figure Int.5). There may be a product issue or an installation issue with this flooring. There were observed locations where corners had chips, and some seams were slightly open.

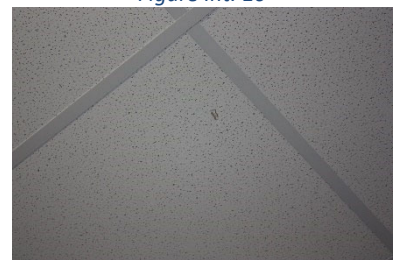
Figure Int. 11

There was some small damage on a few tiles observed. Small damage does not need to be remediated, but periodic visual inspection of ceiling tiles is recommended to maintain aesthetics.

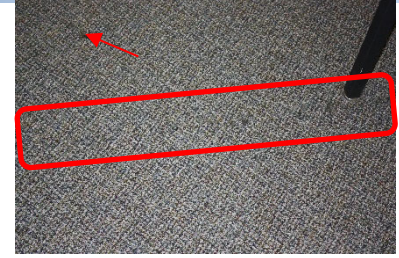
Figure Int. 12

- Classroom Floors:** There is sheet carpeting in some locations. In-room MA204, the sheet carpet has both stains, and the seam is fraying in one spot (Figure Int.12). There was also cracking in the concrete slab beneath the carpet that was detected during the survey by visible and tactile buckling.

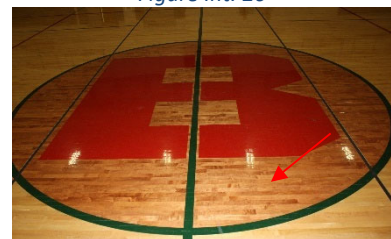
Figure Int. 27

The flooring is in good condition and has light scratches and scuffs (Figure In.27). No immediate concerns for the floor finish were observed during the survey visit.

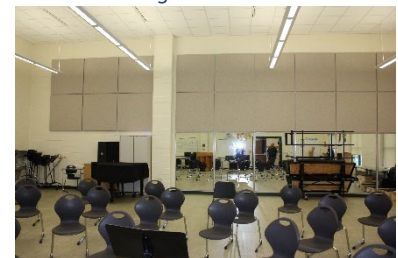
Figure Int. 32

The lighting installed is a bidirectional light, and the housings cut off the sides limiting the light distribution. It is recommended to do a lighting study to make sure the lighting is adequate for the task of reading sheet music.

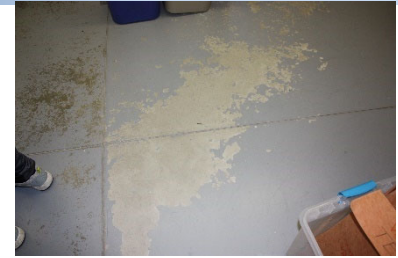
Figure Int. 35

The floor is painted concrete floor slab (Figure Int.35). The painted finish is severely chipped and flaking. This is likely due to the moisture level in the concrete when it was originally painted. It is recommended to refinish the floor. One popular option is to polish the concrete and sealing with clear epoxy. Additionally, decorative epoxy flooring is also a popular modern flooring installation for art rooms.

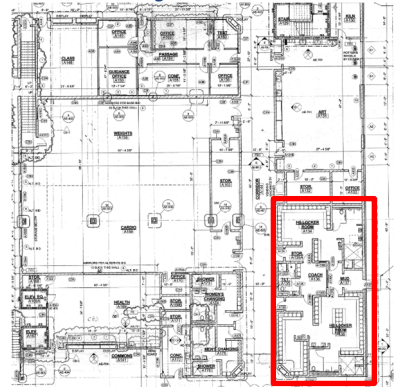
The public access to the fitness center takes users through portions of the school. This is an unsecured condition, and a new solution should be considered. The designated high school locker rooms located east of the fitness center are reported as very underutilized.

Potentially, these locker rooms could be reconfigured to allow the public to use them in conjunction with the fitness center, and a segregated entrance could be provided for public access. Additionally, the adjoining corridor can then have secured access installed.
