## Berlin Area School District Athletic Fields and Structures

### **Field & Structures Overview:**

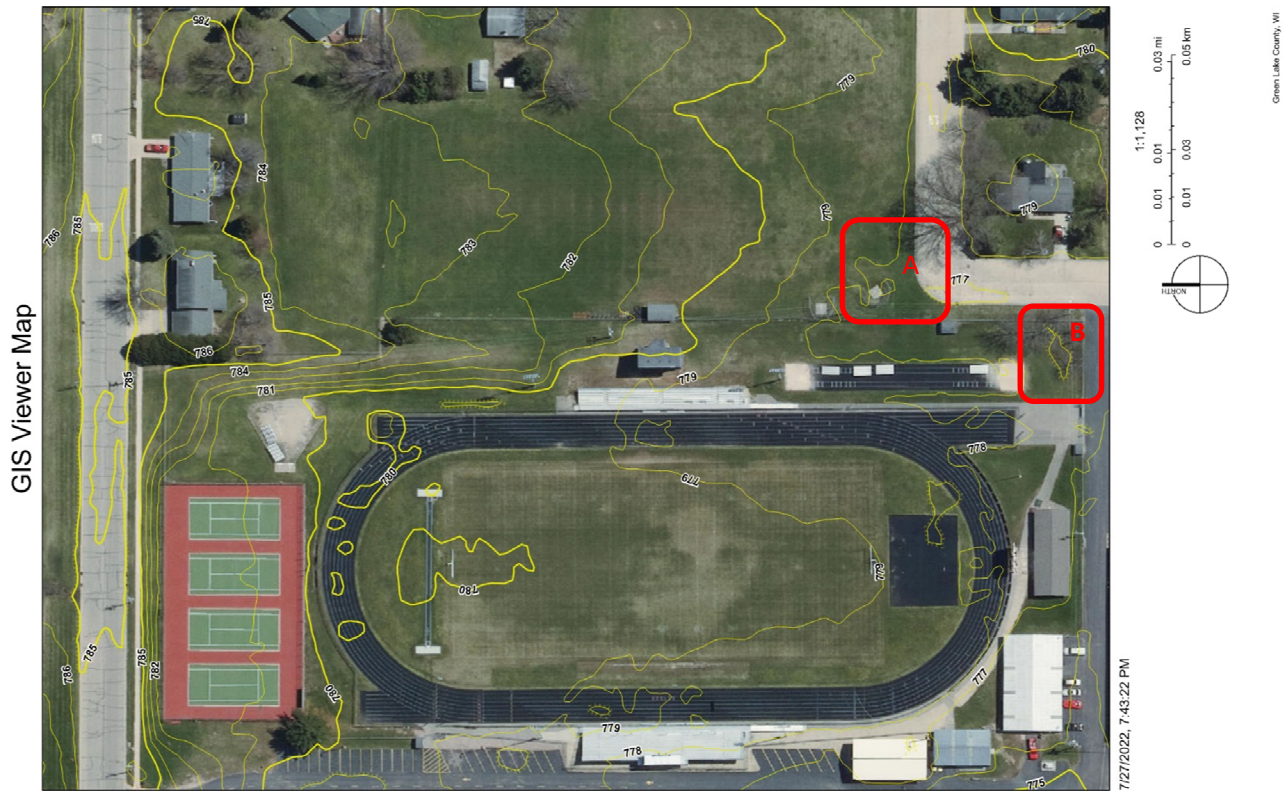
- **Grading Issues:** There are a couple of low spots in the grading that pools water during storm events. Location B above and in Figure 1 does not impede the track & field events, but the long jump pit is very close to this grading depression. Location A above is a more critical condition. This area does get flooded during a storm event and can render the discus stations unusable.

- Location A needs to be regraded, so there is no ponding to impede the track and field events.

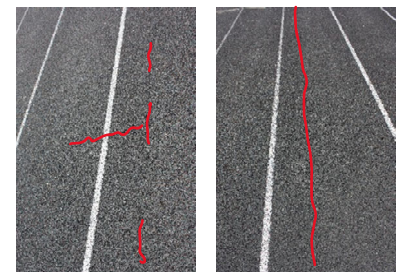
- **Oval Track:** The track was reported to have recently been resurfaced. Figure 2 highlights two locations where cracks are forming in the running surface. These can potentially get worse if the cracks reach the subgrade and freeze/thaw conditions have the running surface.

- The cracks need to be filled or repaired by the appropriate contractor to prevent any further damage.

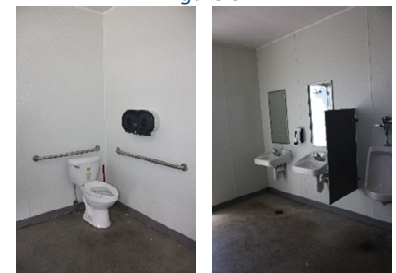
Figure 9

The restrooms on the east end of the concession stand are ADA compliant (Figure 9). The walls are covered with fiberglass reinforced plastic panels. The floor is bare concrete which will, over time, absorb moisture and create orders, particularly in the men's restroom.

- Consider a durable floor covering in the restrooms like epoxy or at least a tile.

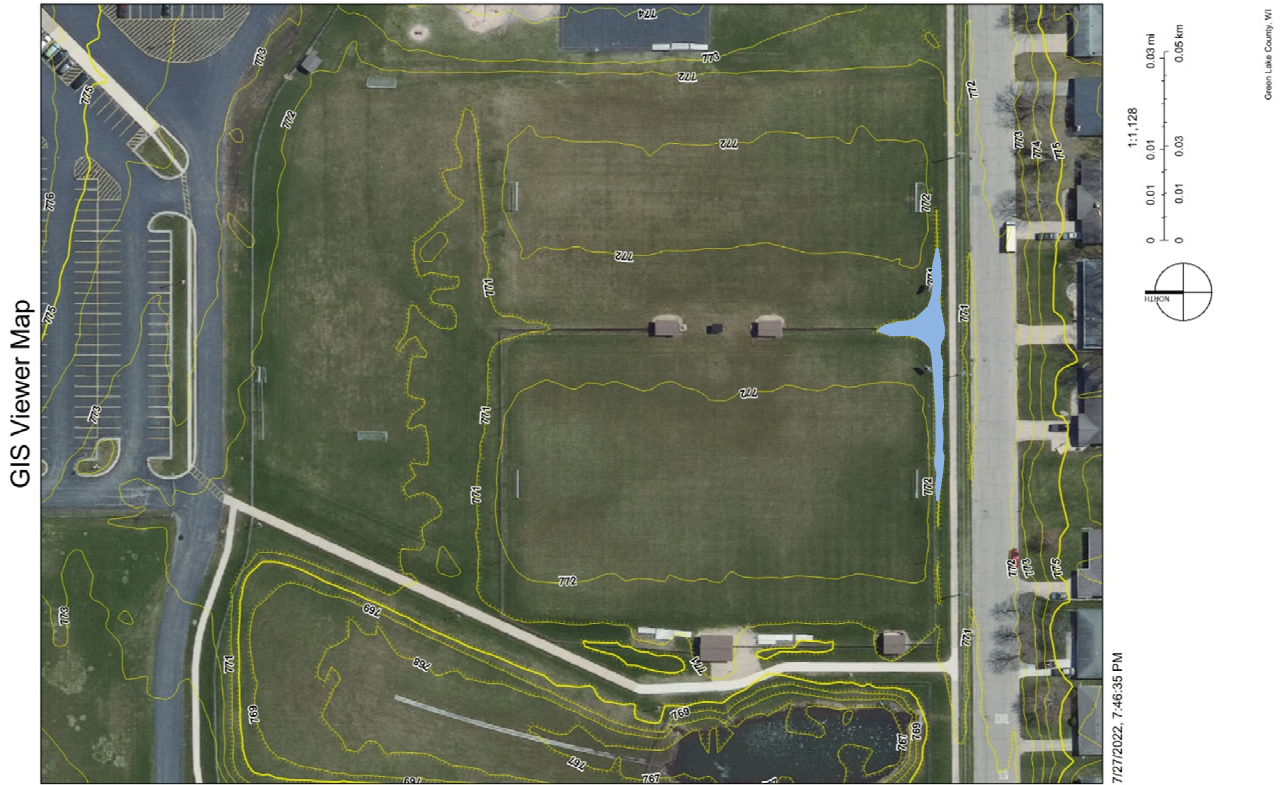
- **Grading:** The soccer fields are graded well, and the stormwater shed of the field flows to the west and into the retention pond. The highlighted blue area above is an enclosed depression and could potentially pond stormwater.

- No immediate maintenance is imperative currently.

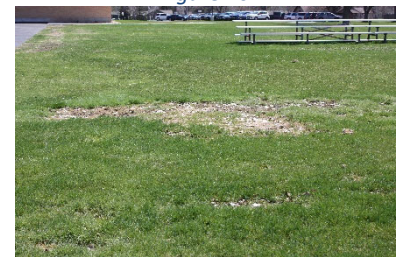
Figure 11

Some bare patches may need additional grass seed.

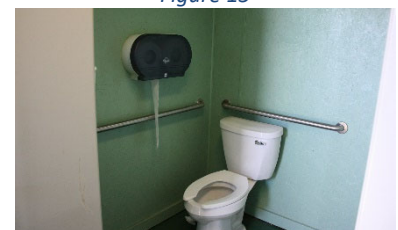
Figure 16

The painted floor is flaking and chipping. The interior walls are painted OSB sheathing, which isn't a good finish for a restroom (Figure 16). The fixtures are installed to be ADA compliant.

Consider adding RFP panels to the walls similar to the restroom at the football field concession stand. Also, consider recoating the floor with a more resilient product.

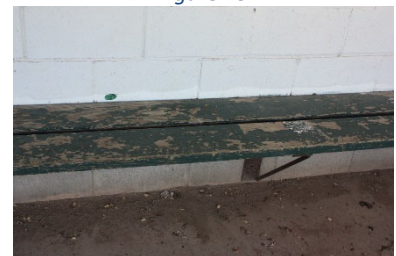
Figure 24

The structure is in good condition, but the benches in the home team dugout are very weathered, and the paint is peeling (Figure 24). The player's bench in the visiting team dugout is newer and in much better condition (Figure 25). Both dugouts have a set of loose wood steps that are in poor condition and quite rotted.

- The wood steps in both dugouts should be replaced. Consider a formed concrete installation in lieu of wood.
- Consider replacing the home team dugout players' bench with similar construction to what is in the visitor's dugout. It is recommended to construct the frame with treated lumber and to construct the seat and shelf surfaces with composite deck boards.

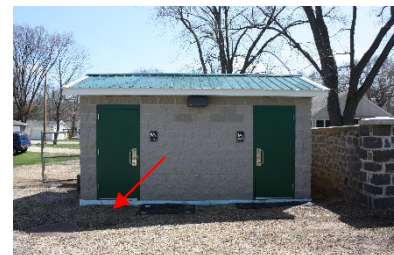
Figure 29

- Restrooms: The restroom facility is constructed from split-faced CMU and a metal roof (Figure 29). The restroom spaces are set up for ADA compliance (Figure 30) but are not accessible at the entries. Access to the restrooms requires a step up (Figure 29). The interiors are painted CMU and a bare concrete floor.

- It is recommended to add a transition ramp to the entries to make the restrooms fully accessible. Many premanufacture products could accommodate this condition.

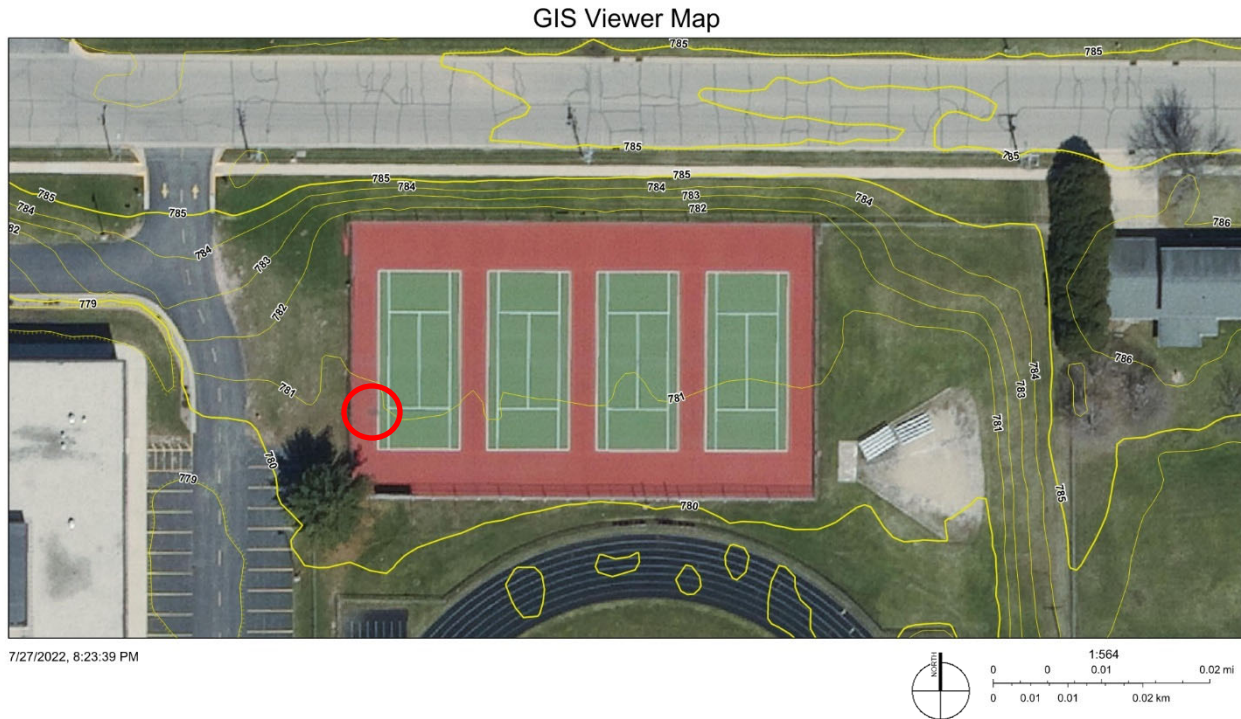
- **Playing Surface:** The playing surface is mostly well drained. There is a low spot on the edge of the westernmost court that caused ponding (Above). The surface was even still wet during the survey visit (Figure 31).

- The cracks in the court should be repaired if they can be. Eventually, the court surface may need to be replaced.

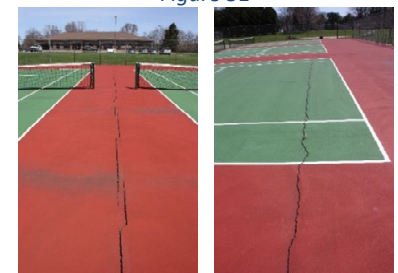
Figure 32

There are cracks in the court playing surface. The cracking between the courts is a concern, but not as much as the cracks that are within the court boundaries. If water infiltrates these cracks and freezes in our climate, it will cause heaving. The court surface can crumble and become uneven, making it unsafe for play.

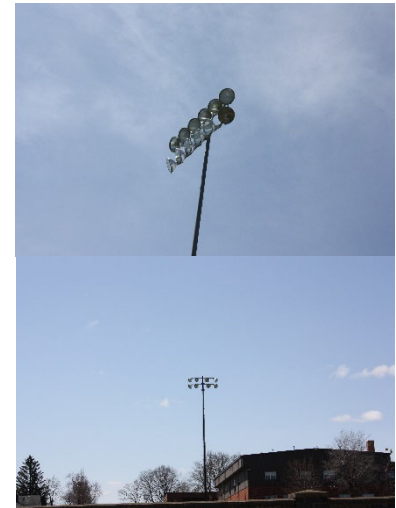
- The outdoor stadium lighting is an older technology that has a shorter life span and uses higher amounts of energy.

- We recommend replacing the stadium lighting at both the baseball field and the football field with LED lighting.
