Berlin High School

Building Overview:

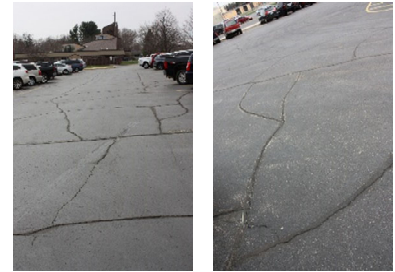
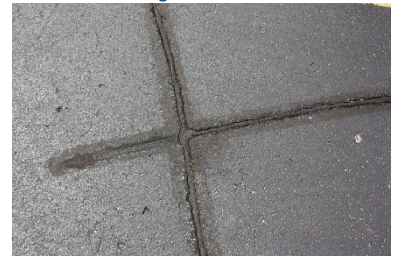
- Asphalt Paving: Asphalt paving on the high school lot is in good condition despite the number of cracks that have been filled (Figure Ext.8 & Ext.9). Not all the surface area was observed; however, when the asphalt cracks and the sections remain large, the serviceability remains better. When smaller sections are formed, and more of a tight-knit spider web type of condition occurs, the asphalt shifts easily under traffic, dislodges, and creates potholes.

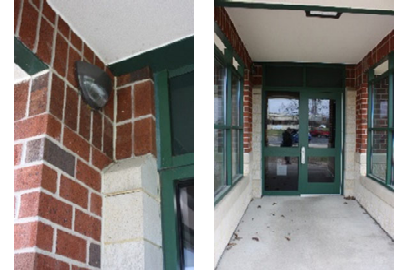
Figure Ext. 10

The sweeps, gaskets, and perimeter sealant are in good condition, and no immediate concerns were observed.

There is no immediate action required.

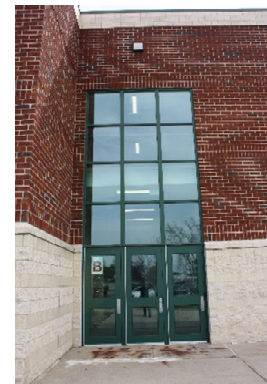
Figure Ext. 11

The door and frame are aluminum and in good condition. The perimeter sealant is intact, not drying out, and should be functioning well. The sweeps at the bottom of the doors have been replaced (Figure Ext.12). The scar from the previous sweep installation could be cleaned up and painted to match, but not necessary for the door to function.

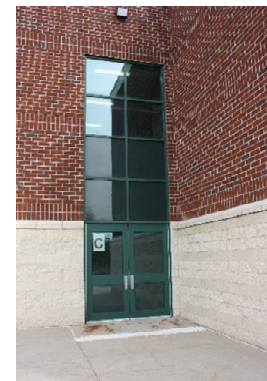
Figure Ext. 13

The stoop has iron oxide staining as described in the exterior concrete assessment. There is also patching around the stoop here to accommodate where the sidewalk has settled (Figure Ext.13).

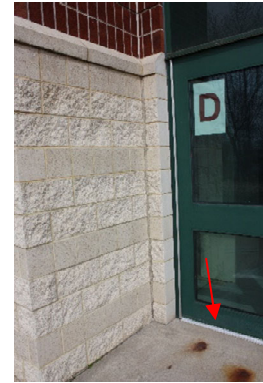
Figure Ext. 14

The door and frame are aluminum and in good condition. The perimeter sealant is intact, not drying out, and should be functioning well. There is some stressed sealant at the base of the door, likely from snow melting salt. The sweeps at the bottom of the doors have been replaced (Figure Ext.14). The scar from the previous sweep installation could be cleaned up and painted to match but not necessary for the door to function.

No action is required for this opening at this time.

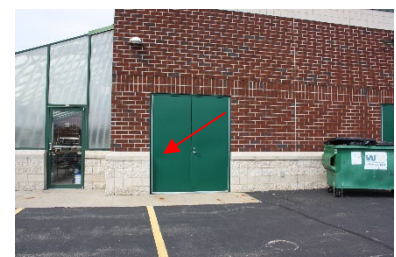
Figure Ext. 17

This is a hollow metal pair of doors in good condition, including the perimeter seals, weather stripping, and sweep. There is a small dent on the western (Figure Ext.17).

No immediate action is required, but addressing the rust at the bottom of the jambs will eventually need mitigation.

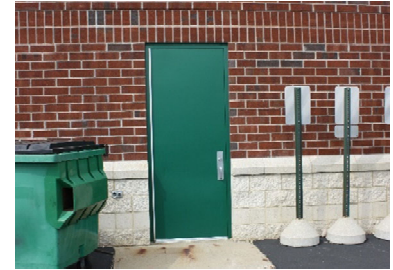
Figure Ext. 18

This hollow metal door is in good condition, including the perimeter seals, weather stripping, and sweep.

There is no immediate action required currently at this opening.

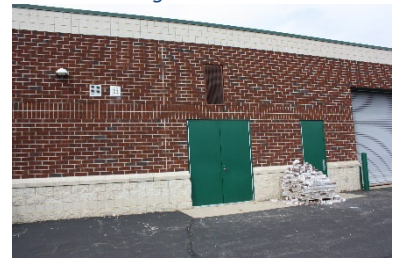
Figure Ext. 19

This is a hollow metal pair of doors in good condition, including the perimeter seals, weather stripping, and sweep.

There is no immediate action required.

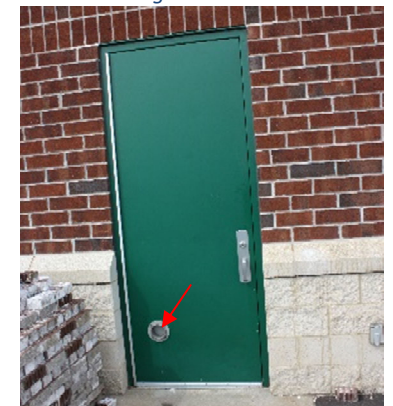
Figure Ext. 20

This hollow metal door is in good condition, including the perimeter seals, weather stripping, and sweep. There is a filtered port on the door that serves some function in the small engines/trades shop area.

There is no immediate action required currently at this opening.

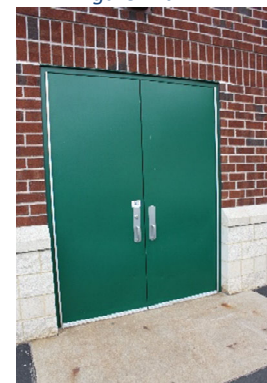
Figure Ext. 22

This is a hollow metal pair of doors in good condition, including the perimeter seals, weather stripping, and sweep. It also appears to have been repainted to cover previously chipped paint.

There is no immediate action required.

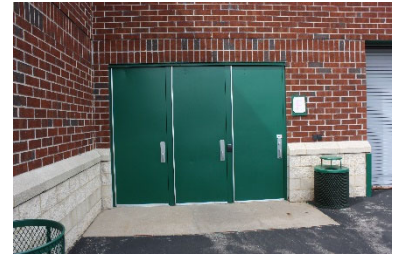
Figure Ext. 23

This is a hollow metal set of doors in good condition, including the perimeter seals, weather stripping, and sweep.

There is no immediate action required. However, there is a security risk that should be addressed.

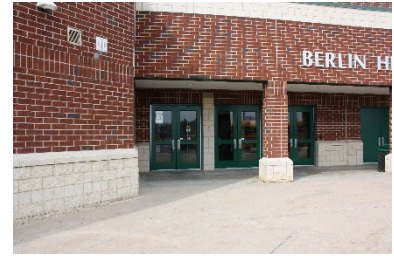
Figure Ext. 28

This is a hollow metal set of doors in good condition, including the perimeter seals, weather stripping, and sweep. The doors are protected from the weather, being set back from the face of the building in an alcove.

There is no immediate action required.

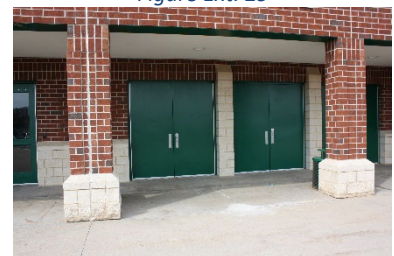
Figure Ext. 30

This is a hollow metal set of doors in good condition, including the perimeter seals, weather stripping, and sweep. There are a few dents in some of the doors, but they do not compromise the integrity of the doors. The doors are protected from the weather, being set back from the face of the building in an alcove.

There is no immediate action required.

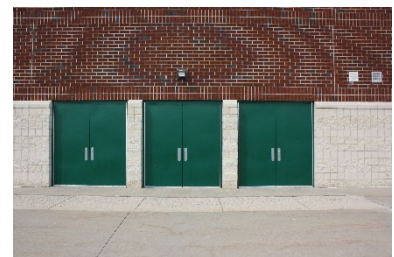
Figure Ext. 32

This is a hollow metal set of doors in good condition, including the perimeter seals, weather stripping, and sweep. There are a few dents in some of the doors, but they do not compromise the integrity of the doors. There is rust at the bottom of the jambs.

No immediate action is required, but addressing the rust at the bottom of the jambs will eventually need mitigation.

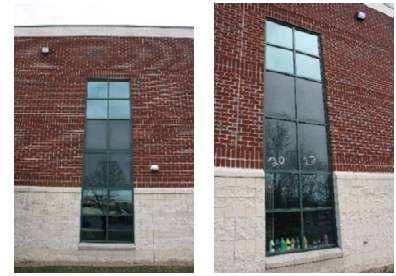
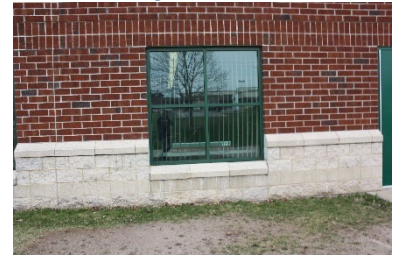
- Window Type 1: The windows are aluminum framed storefront style windows. The perimeter sealant is in similar condition as the aluminum entries. The aluminum entries are also storefront installations. The glazing units are insulating a double pane with spandrel glass on the second-floor plane.

There is no immediate action required.

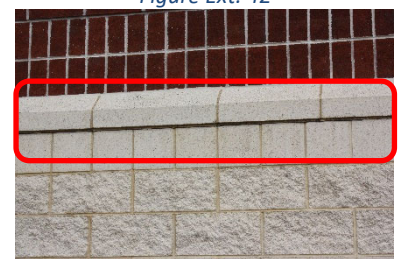
Figure Ext. 43

The horizontal mortar joint below the cast stone accent band is discolored and separated horizontally (Figure Ext.43 & Est.44). This discoloration appears to be mildew or mold. The condition may be caused by water escaping from the wall cavity at these locations.

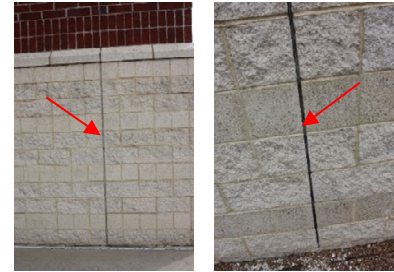
Figure Ext. 48

- **Building Expansion Assemblies:** The control joints installed were correctly spaced and installed. Some of the joints appear newer and may have been replaced. Some of the joints appear original and under the stress of their age (Figure Ext.48).

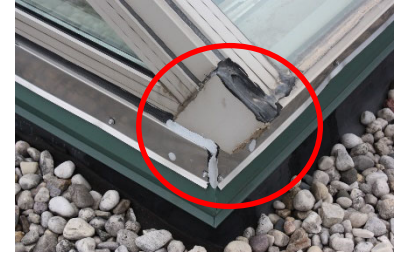
- **Flashings:** Some flashing conditions have needed additional sealant that likely was to mitigate a leak. Figure Ext. 54 is at one of the skylights shared between two classrooms.

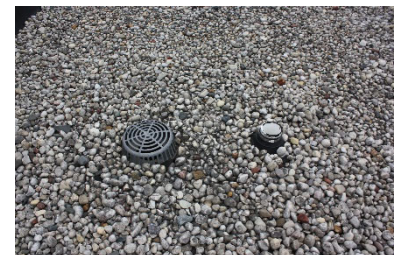
Figure Ext. 57

- **Roof Drainage Components:** The roof drains are in good condition and have the strainer cover over the inlet. The overflow drains do not have a strainer installed over the inlet (Figure Ext.57).

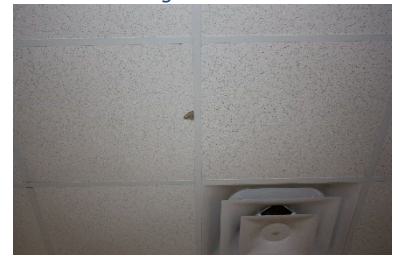
Figure Int. 2

Some damaged tiles might be desirable to be replaced. (Figure Int.2)

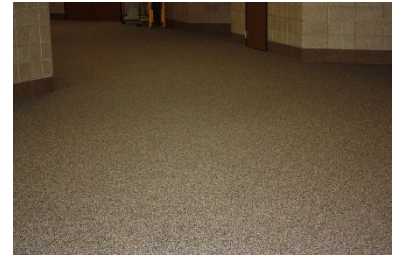
Figure Int. 3

Some of the sheet carpeting is still in fair to good condition (Figure Int.3). the sheet carpeting is more difficult to maintain as an unrecoverable stain or damage to sheet carpeting requires entire sections of carpet to be replaced.

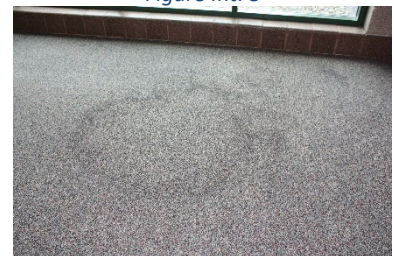
Figure Int. 4

On the second floor, there is a large water stain on the carpet that has been reported from a planter previously installed in the space (Figure Int.4).

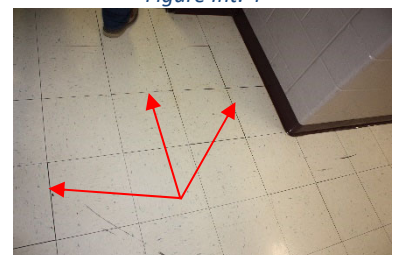
Figure Int. 5

There is original VCT still present in some areas (Figure Int. 5). The tiles have shrunk over time and now have many gaps in the seams. It is recommended to replace this floor tile as maintaining this floor covering will get increasingly more difficult.

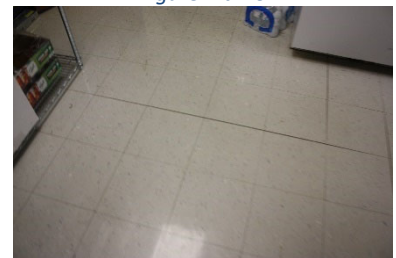
Figure Int. 44

The floors in these spaces are still the original VCT which have shrunken over time, and there are gaps at the seams.

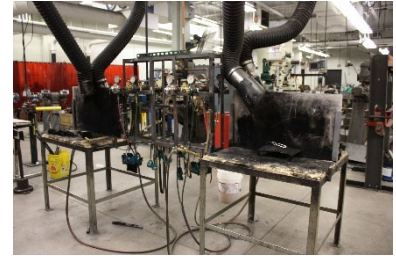
Figure Int. 54

There are additional welding stations that do not have the protection of welding curtains (Figure Int.54). It is recommended to have welding curtains around these stations. It may be desirable to reconfigure the welding stations to be more efficient, with hard walls on the welding booths. It is also recommended to add task lighting at the welding booths.

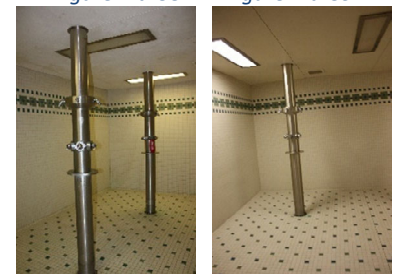
Figure Int. 90

The locker rooms have gang shower posts in the shower rooms. This may limit the use as most students prefer individual shower stalls. It may be desirable to renovate the showers to include individual shower stalls. This may reduce the capacity of the shower room but will increase its usability.
