Clay Lamberton Elementary School

Building Overview:

Existing Condition Assessment:

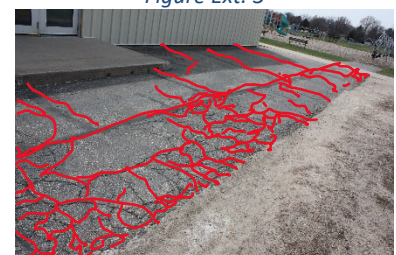
Figure Ext. 3

Some of these deficiencies are being repaired in the summer of 2022, as seen in Figure Ext. 3.

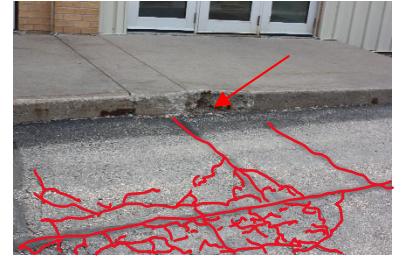
Figure Ext. 5

The main drive aisle in front of the building has some locations that are cracked beyond filling and sealing the cracks. When the cracking in asphalt reaches the point where the cracks form pavement sections with small pieces resembling spiderwebs (Figures Ext.4 & Ext.5), the pieces will eventually dislodge and create potholes.

The Service drive on the north side of the building is in poor condition in several locations (Figure Ext.5 & Ext. 6). The cracks allow water to infiltrate the substrate. In this climate, the water freezes and heaves the asphalt making more cracks. The cold seams between section installations usually are the first cracks to form. One of the concerns with the extent of the north drive isle condition is that the asphalt will begin to dislodge, and the students running out to the playground surfaces will trip on potholes or loose pieces of asphalt.

Sealing the cracks after they first form can slow the deterioration. Eventually, the sections of paving move through freeze-thaw cycles, and the crack gets wider making it more difficult to fill and maintain (Figure Ext.7).

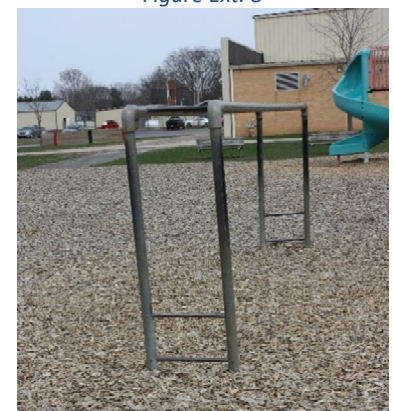
Figure Ext. 9

- **Play Areas and Structures:** The play structures are in fair condition but are showing significant wear (Figure Ext.8 – Ext.10). These structures are dated, and many of the features are not particularly utilized by most of the students.

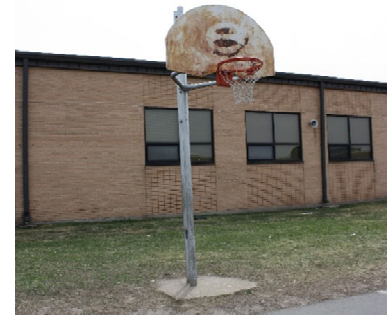
Figure Ext. 10

Paint is faded, chipped, or worn on the older, outdated equipment (Figure Ext.10).

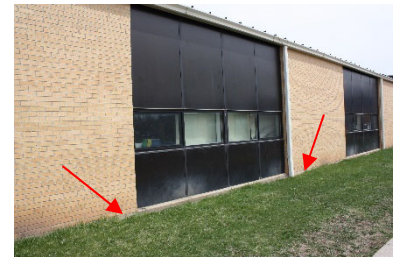
- Wall condition type 2: Masonry walls have been tuckpointed in various locations, repairing cracks in the mortar. Figure Ext. 52 shows another masonry assembly type which is a cavity wall. The wall has weeps installed at the base of the wall to allow any moisture that infiltrated the cavity to get out.

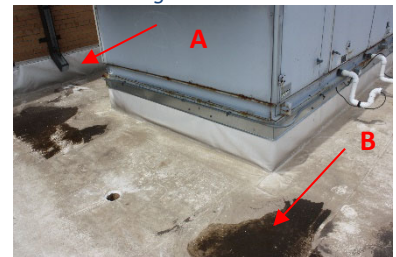
Figure Ext. 68

The natatorium has a ballasted membrane roofing system (Figure Ext. 68). Ballasted systems use stone to hold the loose laid membrane. This roof covering appears to be in good condition as well.

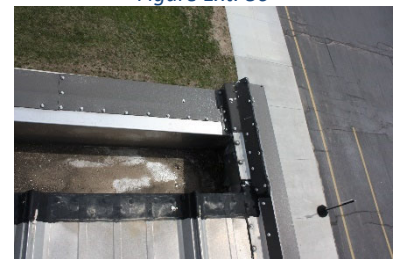
Figure Ext. 87

Heat trace elements are installed in several of the gutters (Figure Ext.87). This indicates an issue with ice forming at the gutters. These are installed to melt any ice that forms in the gutter to prevent ice dams and dangerous snow and ice buildup from sliding off the roof.

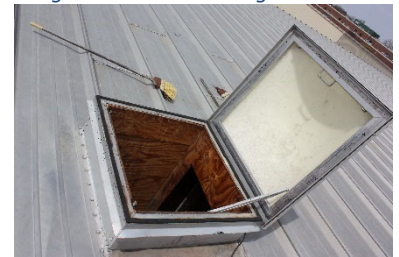
Figure Ext. 92

The roof hatches are located in Figure Ext. 94 by the circled areas. The hatches do not have safety navigation assistance integrated with the hatch making it difficult to transfer from the hatch to the roof surface (Figure Ext. 92).

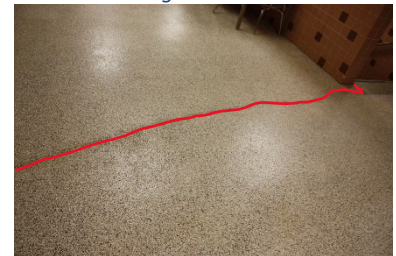
Figure Int. 9

Some cracks do not occur in a straight line, and these are much harder to repair, especially when the crack occurs in a homogenous floor installation (Figure Int.9).

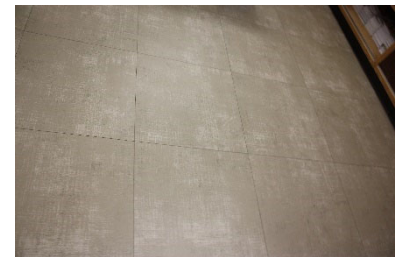
Figure Int. 22

- Classroom Floors: Some of the newer classroom flooring installations are large format Luxury vinyl tiles (Figure Int.22). these floors are in good condition and have no immediate concerns.

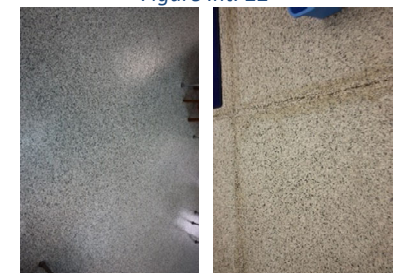
Figure Int. 23

There are classrooms with a homogenous resilient epoxy floor system installed (Figure Int.23). These are typically a good application for a classroom; however, the product or installation method has not lived up to the typical standards. The topcoat appears to be too thin, and the finish is wearing too quickly. These types of floor systems also need the control joints to be planned for. If done properly, an epoxy floor will reduce maintenance costs and be very durable.

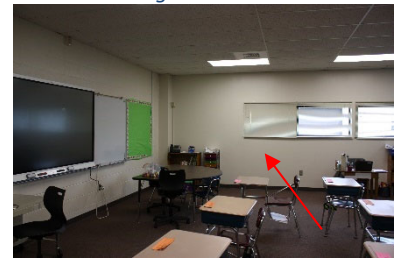
Figure Int. 28

There are also gypsum board walls in various locations (Figure Int. 28). They are in good condition but certainly need to be inspected for damage more often than CMU walls.

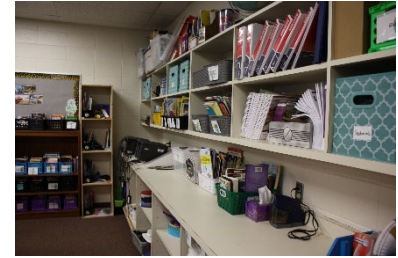
Figure Int. 29

- Casework:** There are open shelves in some of the classrooms allowing for deployment of storage totes and book storage (Figure Int.29). These are plastic laminate and appear to be in relatively good condition. The caveat of open shelving is that the contents cannot be secured, limiting what can be stored on the shelves. Although the benefit is no moving parts to require maintenance.

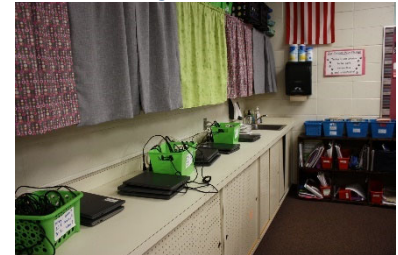
Figure Int. 30

The older casework has laminated tops and peg board style sliding doors (Figure Int.30). These are in fair condition but are starting to show their ages. These pieces of casework are also not lockable, limiting the capacity of securing education items.

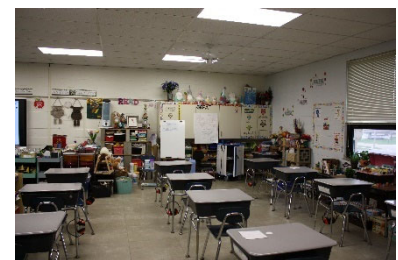
Figure Int. 33

- Classroom Furnishings:** Most classrooms are equipped with individual desks for the students (Figure Int.33). The desks are in good condition and allow for student storage below the desktop.

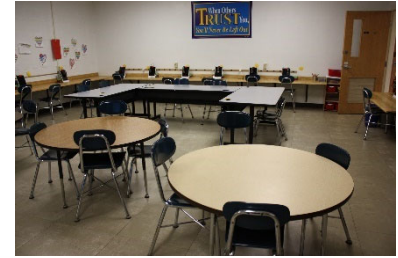
Figure Int. 34

Some classroom spaces have larger tables for more collaborative interaction for the students (Figure Int. 34). This is limited to a few rooms but is generally available. The tables and chairs are in relatively good condition.

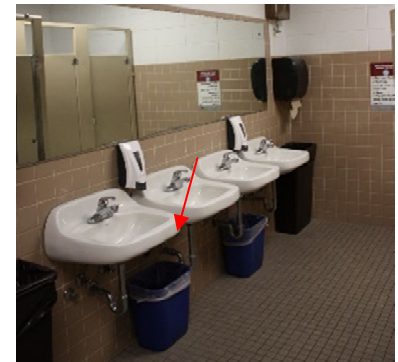
Figure Int. 36

The mosaic tile floor (Figure Int.36) can be problematic for maintenance as the grout can absorb and trap fluids and collect dirt easily, especially older grouts that do not contain epoxy additives. These conditions will, in turn, cause odors to persist in the spaces.

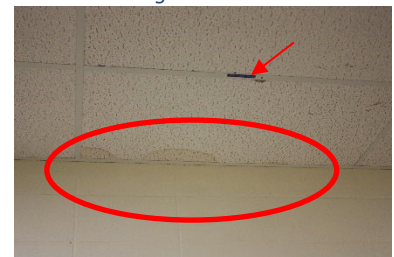
Figure Int. 55

The ceiling is a 2x4 acoustical ceiling (Figure Int.55), and there are some stains resulting from some sort of leak. There are also various scars from tile damage during some process of hanging objects.

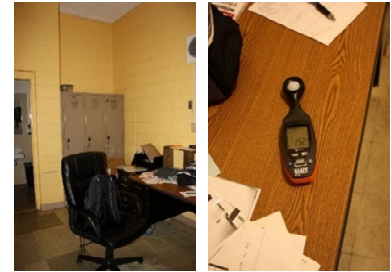
Figure Int. 70

The gym coach's office in the boy's locker room is very dim (Figure Int.70). With the ceiling light on the light meter only reading 2.52 FC (Figure Int.71). This is not adequate task lighting for an individual using this space. There is an observation window that would allow light from the locker room to filter into the office; however, the space should be able to be usable by itself.

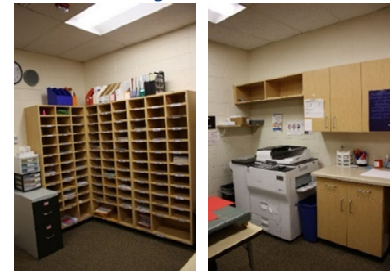
Figure Int. 96

The workroom for the main office is located at the east end of the suite. It has newer casework installed during a renovation (Figure Int.96). The workroom has an adjacent restroom and an additional storage room.

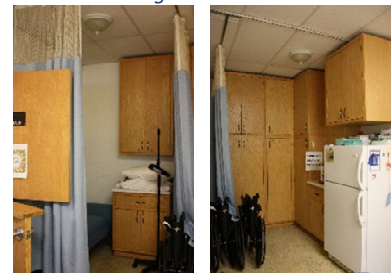
Figure Int. 97

The Nurse's area is not enclosed or segregated from the main reception area (Figure Int.97). This causes issues with noise control being a distraction from staff in the reception area. This also creates a privacy issue for a student that needs to see the Nurse. There is no segregated room to be utilized as a sick room as the cot is in the open. The casework is older and does not appear to have access to a sink except for in the adjacent restroom. The workroom at the east end of the suite and the Nurse's station at the west end of the suite would be better served if the trade places.
