Berlin Middle School

Building Overview:

Existing Condition Assessment:

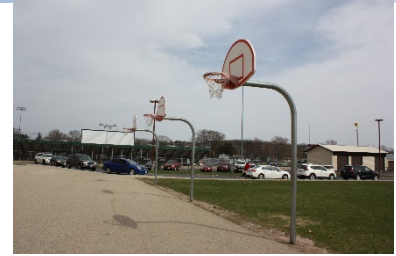
Figure Ext. 6

- Play Areas and Structures: These basketball hoops are newer than the ones at the elementary school. They are in much better condition and have the shooter's square on the backboard. There are no immediate concerns with these.

There is also a Gaga ball pit that is in good condition just south of the basketball hoop area, as well as open grass space for the students to use. No issues with these spaces were currently observed.

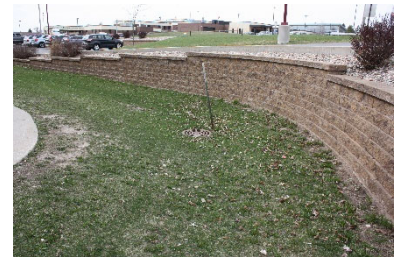
Figure Ext. 7

- Perimeter Foundation & Drainage conditions: At the front of the middle school on the north side of the building, the site required landscaping to adjust for the grade. At the northeast corner, there is a storm inlet that picks up the stormwater that runs around the corner of the building. No issues were observed at this installation.

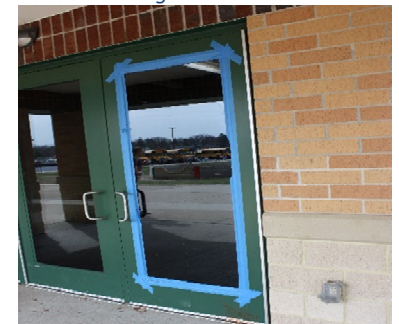
Figure Ext. 12

There is a door panel that has had a glazing unit replaced as it was taped up for glazing sealant curing.

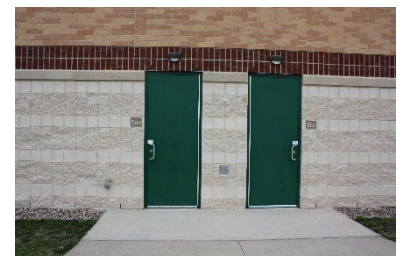
Figure Ext. 14

- Gym Storage Access: This is a hollow metal door opening used to directly access the gym storage from the exterior and as an exit from the space. It appears students have drawn on the door, but the writing is only ghosted in the chalky film that has oxidized on the paint. The balance of the door is in good condition. The sealant, seals, and sweeps are in good condition as they are new from the recent construction.
- Locker Room Access: These two doors are the mud room access for athletic teams to get to the locker rooms during outdoor sporting events. The sealant, seals, and sweeps are in good condition as they are new from the recent construction.

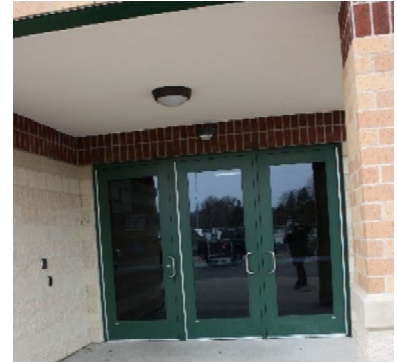
Figure Ext. 16

- Exit/Entrance J: This triple leaf door is an aluminum framed entrance that has card reader access on the southern door leaf. The door is intended for public access to the fitness room. The door also serves as an emergency exit. The canopy protects against the weather allowing fewer salt requirements in the winter. The sealant, seals, and sweeps are in good condition as they are new from the recent construction.

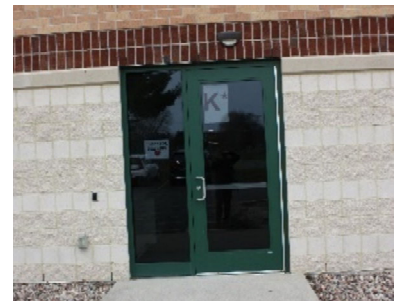
Figure Ext. 17

- Exit/Entrance K: This full-lite aluminum framed entrance has card reader access and serves as an administrative staff entrance. The sealant, seals, and sweeps are in good condition as they are new from the recent construction.

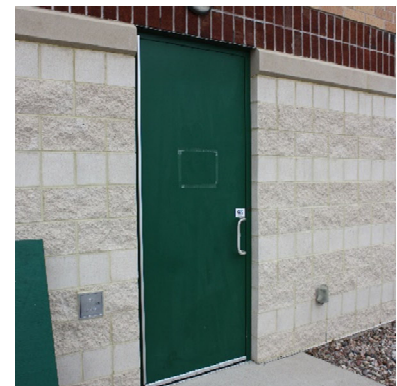
Figure Ext. 18

- Locker Room Access: This door is the mud room access for public access locker rooms. The door has some slightly chipped paint and mastic residue from previous temporary signage being applied to the exterior surface. The sealant, seals, and sweeps are in good condition as they are new from the recent construction.

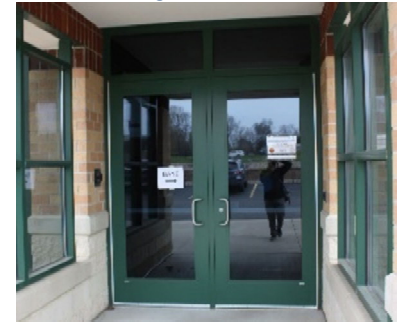
Figure Ext. 20

This is the main security entrance to the school. Visitors arrive at the school and can access the first vestibule immediately. An added level of security could be to have these exterior doors locked and add a video phone to visually verify and verbalize the intent or reason for a visit before any access to the building.

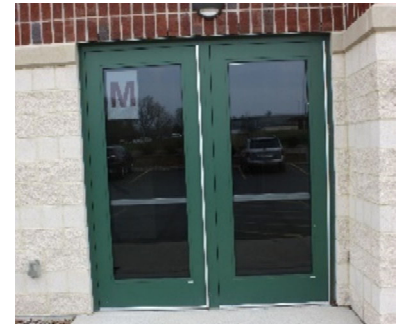
Figure Ext. 21

- Exit M: This opening serves strictly as an emergency exit from the building. It connects to a stairwell from the second floor and to the interior corridor. This is also an aluminum framed assembly with two full-lite door panels. The sealant, seals, and sweeps are in good condition as they are new from the recent construction.

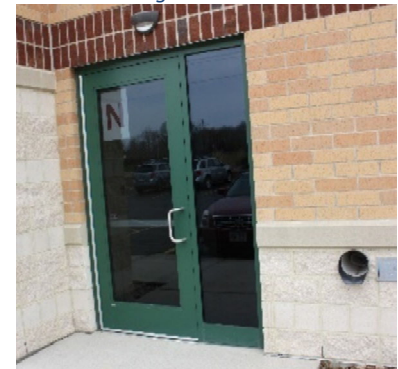
Figure Ext. 22

- Exit N: This opening serves as an emergency exit from the building near the music rooms. There is no lock cylinder or card reader, but this door does possess a handle indicating that it may be used for moving music equipment in an out of the building for off-campus events. This is also an aluminum framed assembly with two full-lite door panels. The sealant, seals, and sweeps are in good condition as they are new from the recent construction.

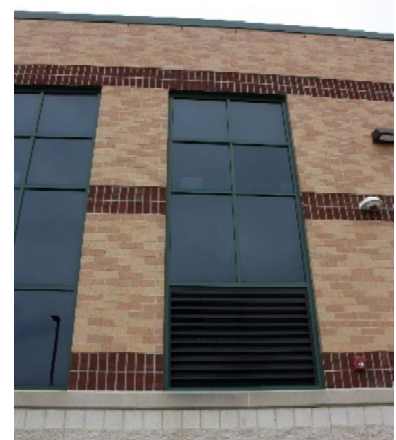
Figure Ext. 23

- Window Type 1: These window openings are aluminum framed and have spandrel panels on the second-floor plane to match the look of the high school windows. The sealant, seals, and sweeps are in good condition as they are new from the recent construction.

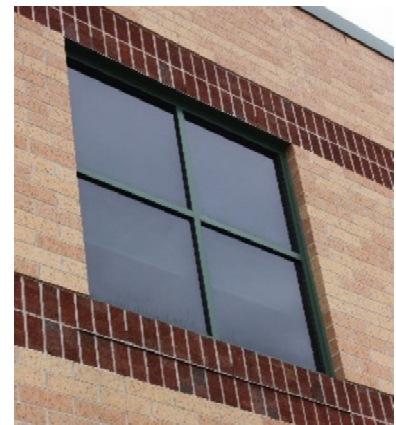
Figure Ext. 24

- Window Type 2: These window openings are aluminum framed to match the look of the high school windows. The sealant, seals, and sweeps are in good condition as they are new from the recent construction.

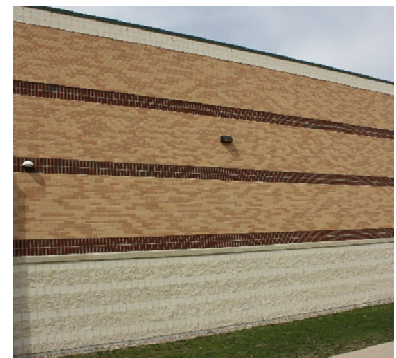
Figure Ext. 25

- Wall condition type 1: Most of the building enclosure falls under one wall type construction. The masonry wall is a cavity wall with CMU structural back-up and brick over a decorative masonry base stacked wall system. The wall consists of a modern cavity wall assembly. The masonry and grout are in good condition as it is still considered new construction.

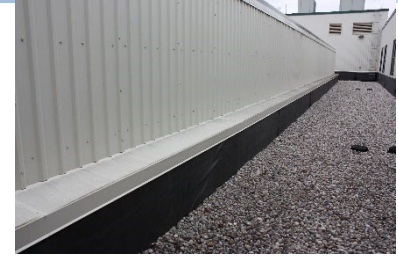
Figure Ext. 26

- Wall condition type 1: In the penthouse areas on the roof, the walls are metal wall panels. These are all in good condition, and no immediate concerns were observed.

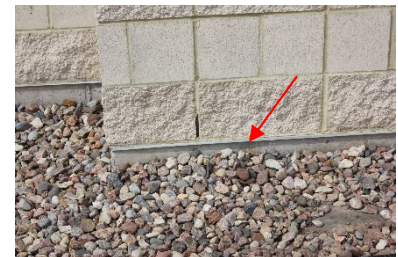
Figure Ext. 29

- Masonry Flashing: The through wall flashing installed at the base of the masonry walls is a stainless-steel flashing (Figure Ext29). This is the preferred material for this application as it is very durable and has a longer life cycle than a coated metal.

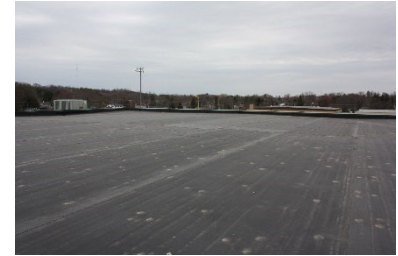
Figure Ext. 33

- Roofing:
- General Roofing condition: The roofing installations on the middle school roof are approximately 7 years old. They should be performing well. No issues were reported or observed during the survey visit.

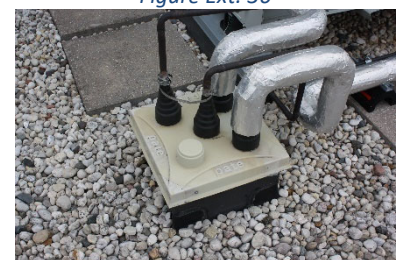
Figure Ext. 37

When multiple penetrations can be clustered together, deploying these curb caps with pipe portals (Figure Ext.37) are very effective.

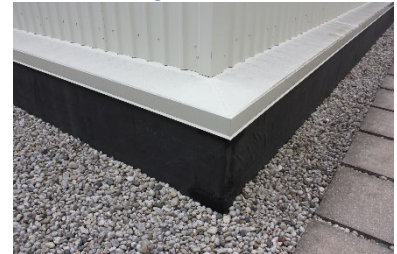
Figure Ext. 39

- Flashings: Other roof flashings included in this roofing installation are the base flashings at the metal wall panels enclosing the penthouses' high roofs (Figure Ext. 39). These flashings are properly seamed and bent and have no observed deficiencies currently.

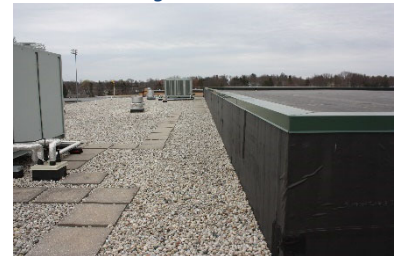
Figure Ext. 40

There is another high roof that has a fully adhered vertical flashing up to the high roof (Figure Ext.40).

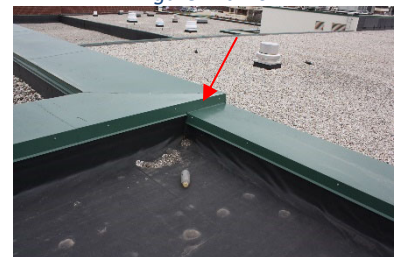
Figure Ext. 41

- Parapet Copings: The coping caps are in good condition and appear properly seamed and mitered. The copings at uneven levels are shingle lapped (Figure Ext.41). This prevents water from infiltrating under the coping cap requiring sealant at the top edge, which eventually can fail like at some locations of the high school roofing.

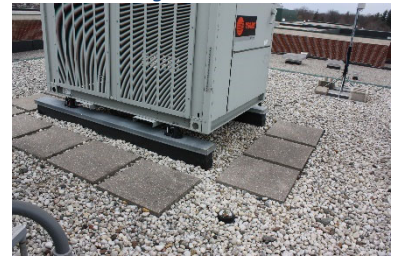
Figure Ext. 46

- Roof Walking Pads: The Highschool roof had very few walking pads, which are on the middle school roof (Figure Ext.46). These are recommended around all mechanical equipment and to and from roof access points to protect the roof membrane as maintenance contractors will be eventually walking on the roof. The middle school has these installed but not on every piece of equipment that might need servicing. We also typically recommend having these lead to the roof drains.

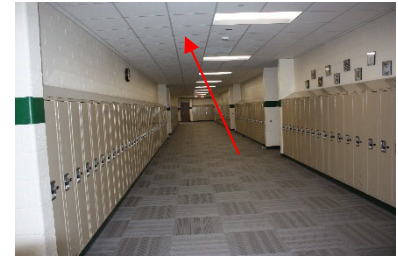
Figure Int. 1

- **Ceilings General:** The common and circulation spaces have a 2x2 acoustical tile ceiling, and it is in good condition. The 2x2 tile will have a longer life cycle than the traditional 2x4 ceiling tile installation.

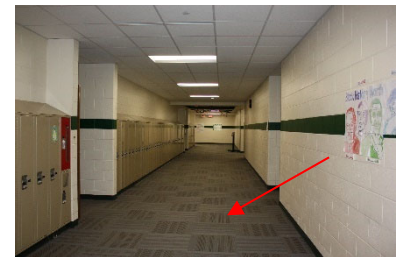
Figure Int. 2

- **Floors General:** There are several types of flooring in the middle school common and circulation spaces (Figure Int.2). Carpet tile is in some corridors and is in good condition. Carpet tile is recommended over sheet carpeting as individual tiles can be replaced when stains and damage occurs.

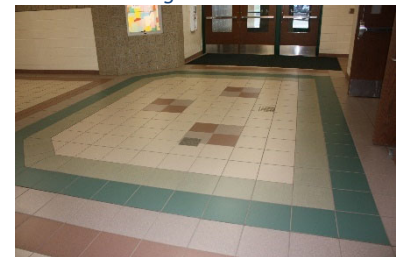
Figure Int. 3

Ceramic tile is also installed in some corridors on the first floor (Figure Int.3). This is a resilient type of flooring, but the grout may require maintenance eventually. If the grout does not have a stain-resistant additive, the maintenance will gradually increase to a higher frequency.

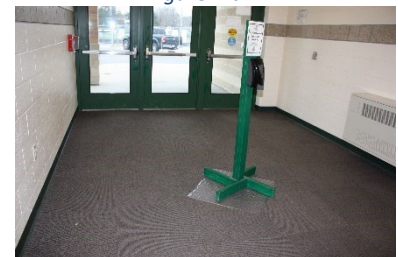
Figure Int. 5

At the vestibules, a durable walk of type carpet tile is installed (Figure Int.5). These are resilient and chemical resistant, making them have a robust life cycle.

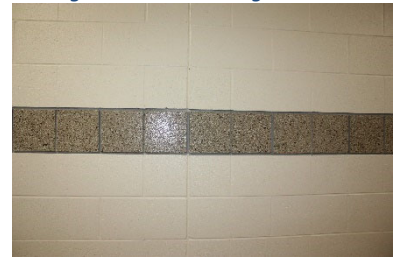
Figure Int. 8

There is an accent stripe on the corridor walls. Some locations have a painted stripe (Figure Int.7), and others have a polished block accent that resembles the CMU in the high school (Figure Int.8).

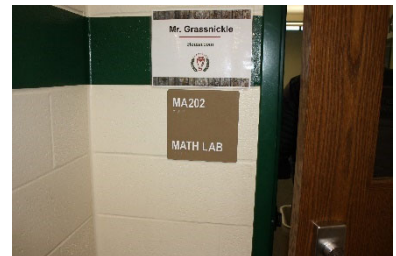
Figure Int. 9

- Classroom Doors:** The doors are wood veneer doors with narrow-lite glass. The doors are in good condition, and no immediate issues were observed currently.

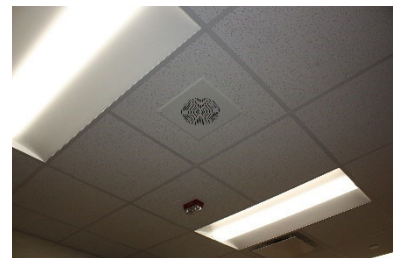
Figure Int. 10

- Classroom Ceilings:** Classrooms have a 2x2 acoustical tile ceiling, and it is in good condition. The 2x2 tile will have a longer life cycle than the traditional 2x4 ceiling tile installation.

There was some small damage on a few tiles observed. Small damage does not need to be remediated, but periodic visual inspection of ceiling tiles is recommended to maintain aesthetics.

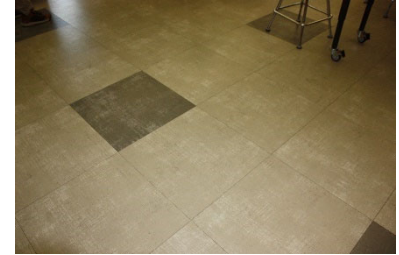
Figure Int. 13

There is Luxury vinyl tile in many of the lab classrooms (Figure Int.13). This tile is usually resilient and requires less maintenance than traditional vinyl composite tile (VCT). There were a few locations where a tile corner was chipped. The damage was small and can be deferred, but it may be desirable to eventually replace individual damaged tiles with attic stock.

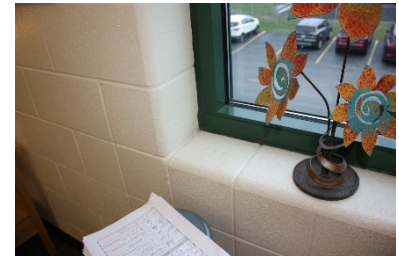
Figure Int. 14

- Classroom Walls:** The exterior and corridor walls are CMU (Concrete Masonry Units) which are painted and very durable (Figure Int.14).

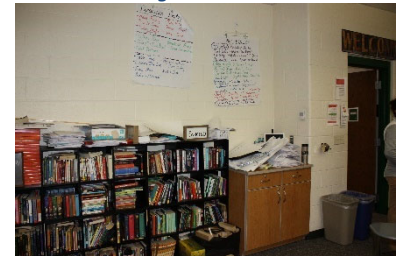
Figure Int. 15

The balance of the walls are framed, painted gypsum board, and are in good condition (Figure Int.15). These walls are in good condition but will need additional maintenance as they can be more easily damaged than the CMU walls.

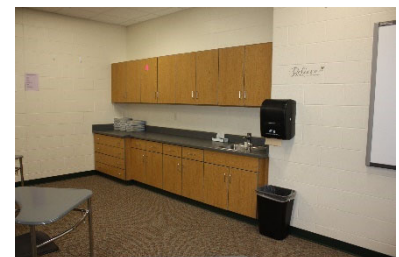
Figure Int. 16

- Casework:** The wood look plastic laminate casework is in good condition (Figure Int.16). There are select cabinets with lockable cylinders, which are important for securing classroom supplies and teachers' items.

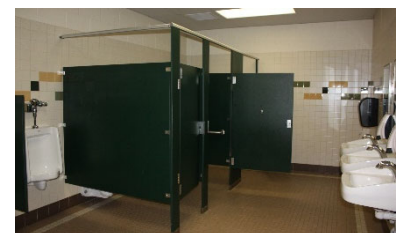
Figure Int. 21

- **Restrooms:** The restrooms are clad in ceramic tiles on the floor and the ceilings. The partitions are still in good condition (Figure Int.21), and the urinals have privacy screens (Figure Int.22).

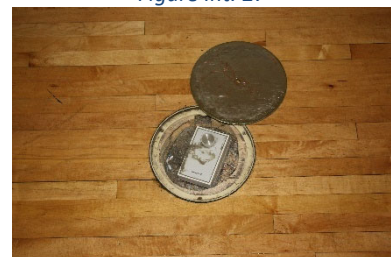
Figure Int. 28

The wood athletic floor has a ventilation system installed (Figure Int.28). This is designed to pull air under the flooring sleeper supports to ensure that the flooring stays dry and that humidity does not have adverse effects on the wood flooring.

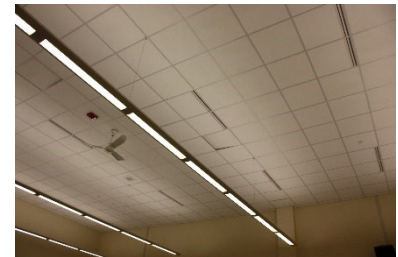
Figure Int. 31

- **Music Room:** The music rooms are tall spaces that have acoustical tile ceilings (Figure Int.31) and sound dampening panels on the walls for added acoustical control (Figure Int.32).

The lighting installed is a bidirectional light, and the housings cut off the sides limiting the light distribution. It is recommended to do a lighting study to make sure the lighting is adequate for the task of reading sheet music.

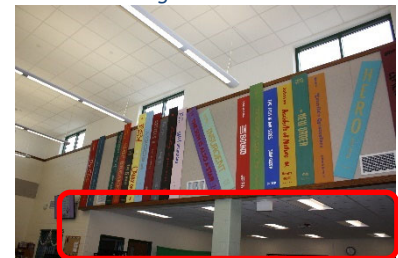
Figure Int. 37

The portion of the media center with the lower ceiling is used as an instructional space (Figure Int.37). The MC staff reported the benefit of having this space separable.

- Media Center: No recommendations currently. Consider adding a folding partition or folding glass partition to separate the instruction area from the main media center.

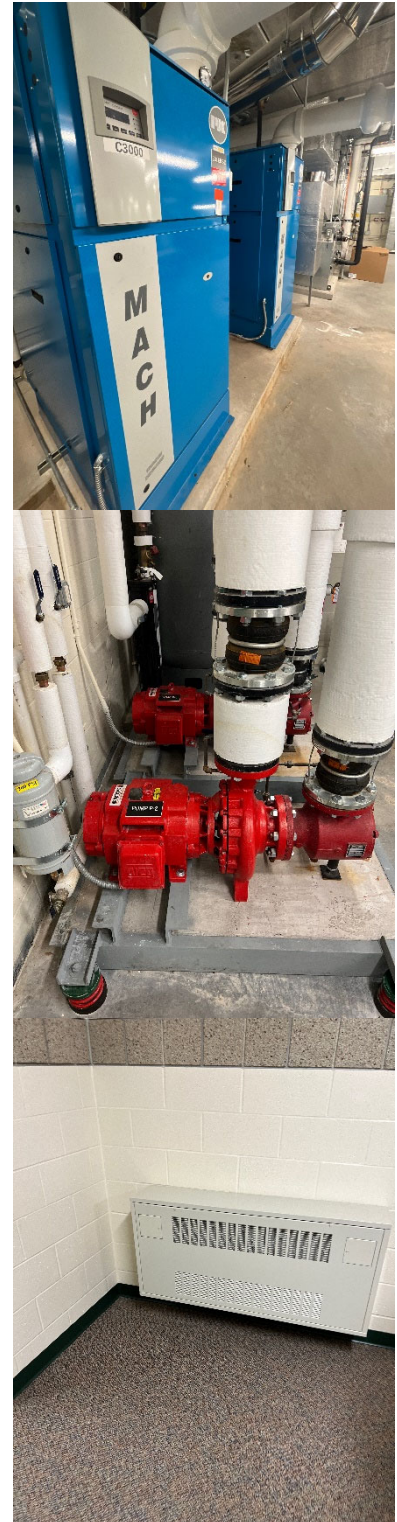
- These boiler plants provide hot water heating to the building through unit HW heating coils located in VAV terminal units, unit heaters, and cabinet unit heaters.
- The boiler plant serving the building consists of two (2) HW boilers from PK. The boilers are 2,850 MBH input each and up to 94% efficient. The boilers were installed in 2014 and are in good condition.
- The heating plant capacity equates to roughly 58 BTU/SF (output), which is slightly more than typical heating requirements in Wisconsin of approximately 40 BTU/SF, which provides some redundancy. A holistic approach is required when assessing the heating capabilities of the boiler plants.

- The hot water plant distributes hot water to the building by two (2) inline primary pumps and two (2) base-mounted distribution pumps. The inline boiler pumps are at a constant speed. The base-mounted distribution pumps are powered by variable frequency drives. The pumps are in good condition.
- The Middle School has a series of HW cabinet unit heaters which are located at the building perimeters and at entryways. These units are in good condition but, in almost every case, serve transitional spaces.
- The air handling units (AHUs) are equipped with HW heating coils that provide all the space heating for single zone and variable air volume systems.

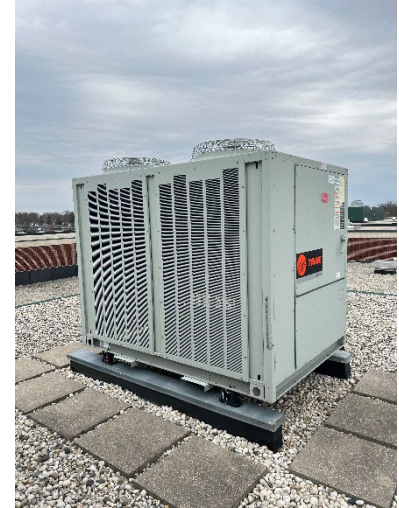
- All occupied spaces within the school are provided with air conditioning from (5) split DX air-cooled condensing units.
 - CU-1: 50 Tons
 - CU-2: 25 Tons
 - CU-3: 150 Tons
 - CU-4: 40 Tons
 - CU-5: 60 Tons

- The condensing units are all from the renovation project in 2014 and are in good condition. All units are located on the middle school roof on equipment rails with easy access for service.

- One (1) split DX condensing unit is located on the roof and serves the IT closet. This unit is in good condition and should last the District for some time with proper maintenance.

None at this time.

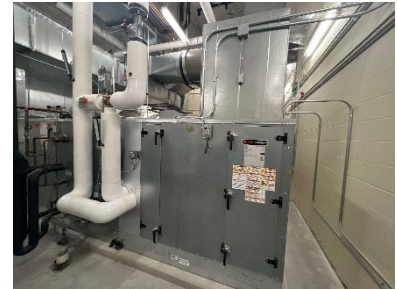
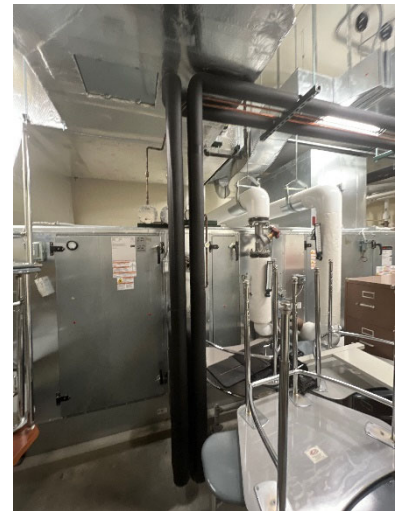
- All areas of the school are served with overhead air distribution from the AHUs and terminal equipment. The AHUs typically serve multiple spaces and utilize variable air volume (VAV) boxes with hot water reheat coils serving one or more rooms. The VAV boxes vary airflow and air temperature supplied to the space(s) to maintain temperature setpoints.
 - AHU-1: Multizone Variable Air Volume
 - AHU-2: Multizone Variable Air Volume
 - AHU-3: Multizone Variable Air Volume
 - AHU-4: Multizone Variable Air Volume
 - AHU-5: Multizone Variable Air Volume
 - AHU-6: Single Zone

- Continue maintaining the existing HVAC equipment.

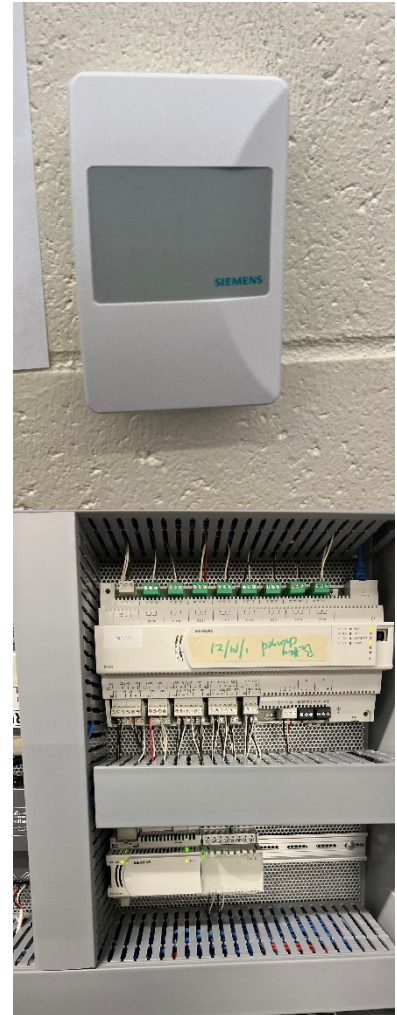
- The building controls systems are DDC with Siemens (BAS) interface. This system is comprehensive over all major HVAC equipment with zone/space controllers. The BAS appears to have the ability to fully control, trend, alarm, and notify the Customer of needs and inconsistencies in the system.

- No recommendations currently.

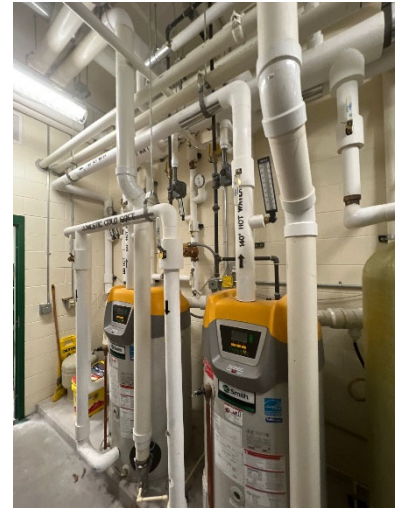
- The building is served by two high-efficiency gas-fired water heaters and recirculation pumps. These units are in good condition.

- No recommendations currently.

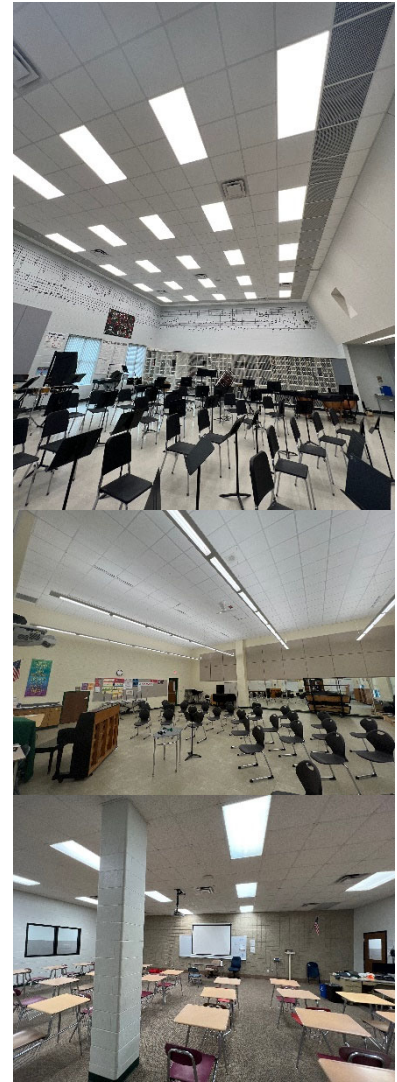
- All of the interior lighting appears to be LED fixtures that illuminate the space learning environment. Most of the spaces were observed to have adequate light levels.

- No recommendations currently.
