## Berlin Area School District Athletic Fields and Structures

### **Field & Structures Overview:**

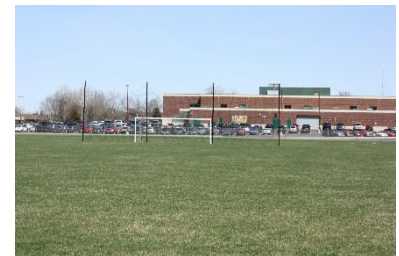
Figure 10

- **Grading:** The soccer fields are graded well, and the stormwater shed of the field flows to the west and into the retention pond. The highlighted blue area above is an enclosed depression and could potentially pond stormwater.

Some bare patches may need additional grass seed.

- No immediate maintenance is imperative currently.

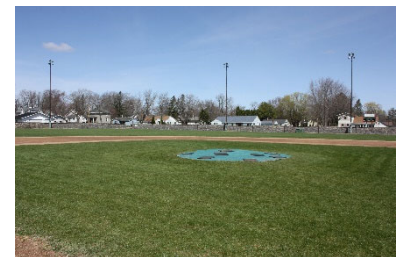
Figure 18

- **Field of Play:** The outfield and infields are well graded and, judging by the topography, has no areas where ponding should occur. The baselines appear graded and flat.
  - No immediate concerns were observed currently.
- **Perimeter Wall:** The original football field had a granite stone wall at the perimeter, which has been maintained since becoming the baseball field. The walls have been repointed over the years and are in fairly good condition.
  - No immediate concerns were observed currently. Continue the diligent maintenance to keep this nice feature looking great.

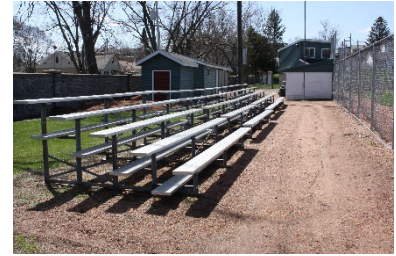
Figure 20

- **Bleachers:** The bleachers are common free-standing aluminum bleachers. There are four sections along the third baseline for the visiting spectators and five along the first baseline for the home team.
  - No immediate concerns were observed currently. Consider adding a safety rail at the top bench. The

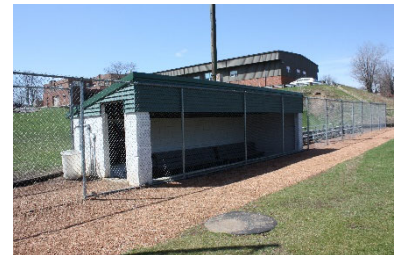
Figure 23

- **Dugouts:** The dugouts are a robust CMU construction with paint that is fading a little. The balance of the construction is vinyl sided with a shingled roof.

The structure is in good condition, but the benches in the home team dugout are very weathered, and the paint is peeling (Figure 24). The player's bench in the visiting team dugout is newer and in much better condition (Figure 25). Both dugouts have a set of loose wood steps that are in poor condition and quite rotted.

- The wood steps in both dugouts should be replaced. Consider a formed concrete installation in lieu of wood.
- Consider replacing the home team dugout players' bench with similar construction to what is in the visitor's dugout. It is recommended to construct the frame with treated lumber and to construct the seat and shelf surfaces with composite deck boards.

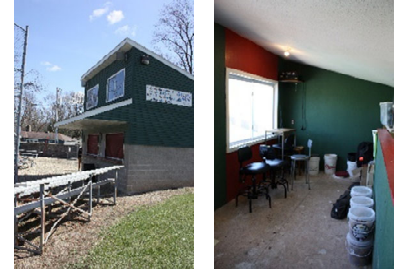
Figure 26

- Press Box Concessions: The press box is a two-story wood-framed structure with the concession stand on the first floor having a split-faced CMU base. The building is in fairly good condition. The access door at the rear was installed with just the primer and never painted. There is no rust on the door and frame. The overhead rolling gates are adequate and functioning. The walls are exposed, and unfinished CMU and OSB which does not convey a sense of cleanliness, and there is no ceiling, only a bare structure. The press box on the second floor has painted walls but not a finished floor.

- Consider painting the walls and ceiling structure in the concession stand space white for a more finished look. This will also give the customers a better experience as well as better light from reflection for the workers in the concession stand. Consider an outdoor carpet on the floor in the press box.

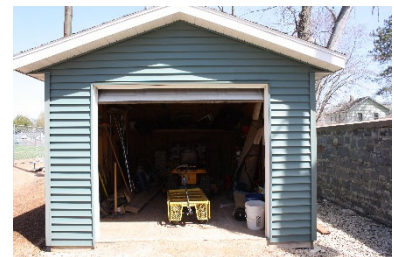
Figure 28

- Equipment Storage: These storage buildings are in good condition. They are used to hold the equipment for the field prep and practice equipment.

- No immediate concerns were observed currently.

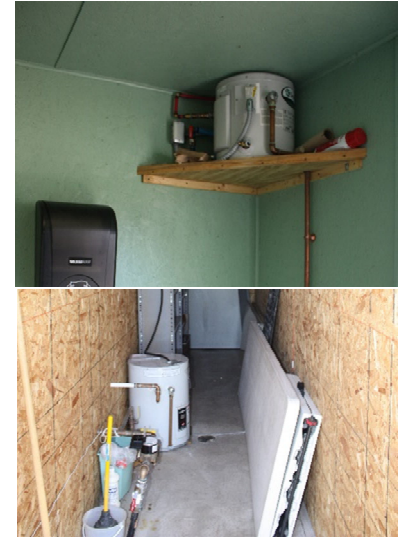
- The restrooms are served by a small point-of-use tank heater in the remote restrooms and a mid-sized tank heater in the concession stand.

- No recommendations currently. Consider installing tankless point-of-use water heaters for the outdoor athletic restrooms.
