Berlin High School

Building Overview:

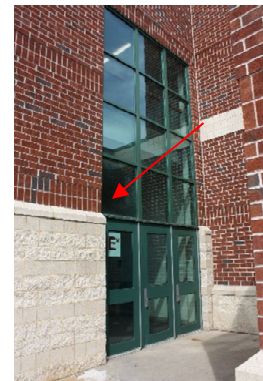
Figure Ext. 15

The door and frame are aluminum and in good condition. The perimeter sealant is intact, not drying out, and should be functioning well. The insulated glazing unit above the western door leaf appears to be failing (Figure Ext.15). There are deposits on the interior surface of the glazing due to the glazing seal being compromised, allowing condensation between the glass.

The compromised glazing unit may need to be replaced. However, there is a security risk that should be addressed.

- **Windows General Conditions:** Consider replacing the failing glazing units that have compromised glazing seals. This will increase the thermal performance of that glazing unit to at least the original performance.

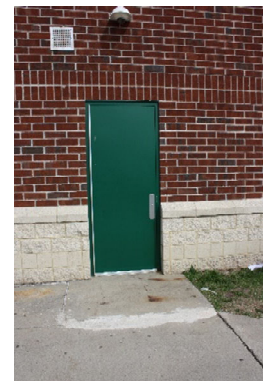
Figure Ext. 16

This hollow metal door is in good condition, including the perimeter seals, weather stripping, and sweep. There is some rust forming at the base of the frame jambs with bubbling paint (Figure Ext.16).

No immediate action is required, but addressing the rust at the bottom of the jambs will eventually need mitigation.

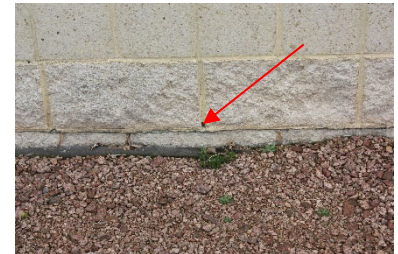
Figure Ext. 45

- Wall accessories:
- Masonry Weeps & Vents: Weeps appear to be installed at the bottom of the decorative concrete block (Figure Ext.45). However, the frequency of the installation is not apparent. The mortar joint at the bottom of the wall is mostly open and may be acting as a naturally formed weep location.

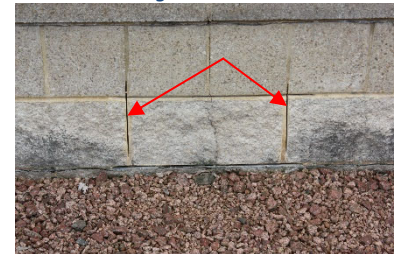
Figure Ext. 46

In at least one location, the head joints at the bottom block have been saw cut (FigureExt.46). This may have been done to relieve water head pressure if water had been trapped in the cavity.

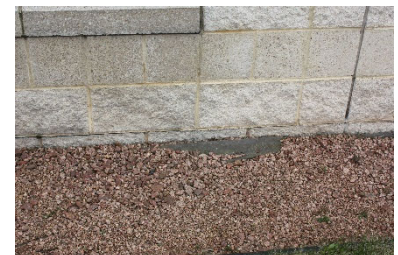
Figure Ext. 47

- Flashing: A flexible through wall flashing that terminates behind the face plane of the masonry. This type of installation is usually acceptable, but without the benefit of a drip edge, there is a chance of capillary action that could pull water in under the flashing. It is not known to be the case with this wall.

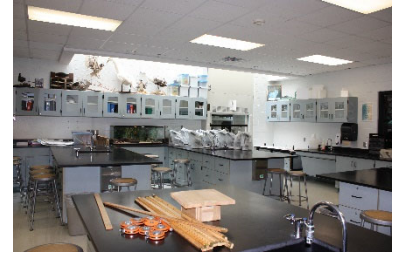
Figure Int. 17

- Classroom General Condition:
- Classroom Doors: The classroom doors are typically flush wood veneer (Figure Int.17). The doors are generally in good condition, and no immediate action is required. We recommend inspecting the wood doors for any chips in the veneer and keeping up on maintenance. The glass in the side-lites is not likely ballistic-rated glazing. This is a concern for active shooter safety.

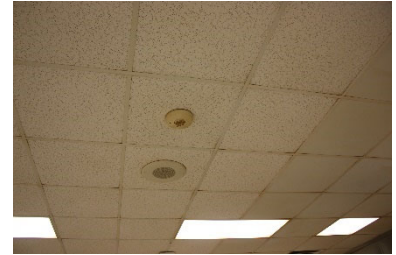
Figure Int. 18

- **Classroom Ceilings:** The majority of the 2x2 ceilings (Figure Int.18) are in good condition, with some stained and damaged tiles in select locations that can easily be swapped out with new tiles.

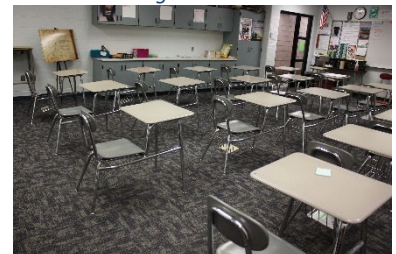
Figure Int. 23

- **Classroom Floors:** There is original VCT still present in some classrooms (Figure Int. 20, Int.21, & Int.23). The tiles have shrunk over time and now have many gaps in the seams. It is recommended to replace this floor tile as maintaining this floor covering will get increasingly more difficult.

Many classrooms have sheet carpeting installed (Figure int.23). Some of the sheet carpeting is still in fair to good condition. The sheet carpeting is more difficult to maintain as an unrecoverable stain or damage to sheet carpeting requires entire sections of carpet to be replaced.

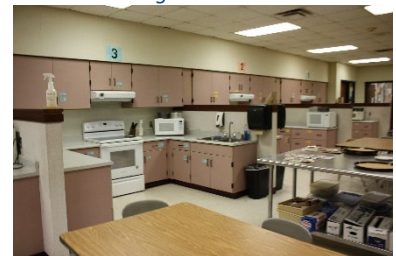
Figure Int. 57

There are several residential kitchen stations. The plastic laminate countertops are beaten up a little and have delaminated countertop sections, especially at some of the edges.

- Casework: Replace the countertops in the Culinary/Family and Consumer Education room. These countertops are in the worst shape in the classrooms. Plastic laminate would provide a lower first cost for countertops, but a solid surface will provide a longer-term solution with lower maintenance costs.

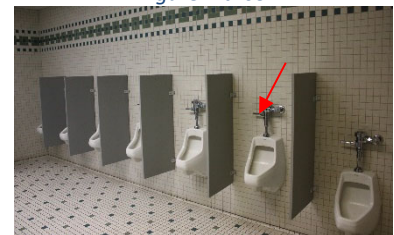
Figure Int. 64

The metal toilet partitions are in fair condition (Figure Int.62), and there is an accessible toilet stall available (Figure Int.63). The wall-hung urinals in the men's restroom have privacy screens installed (Figure Int.64). All these features make the restroom compliant with modern building codes.

The flush valve (Figures Int.63 & Int.64) and faucets (Figure Int.60) are manual controls. We recommend installing touchless controls for the water delivery controls for water savings and to reduce the number of surfaces occupants would touch. This will reduce the spread of bacteria and viruses. The faucets are the push-down spring controls. At the survey site visit, a stuck open control was observed, causing water to run continuously. This is where water savings could be improved upon.

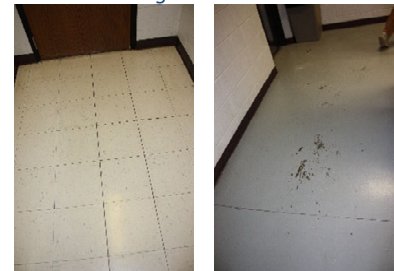
Figure Int. 88

The passage entry to the locker rooms is the original VCT. This floor covering is shrunken, and gaps are present between the tiles (Figure Int.88).

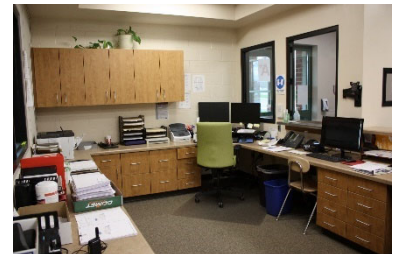
Figure Int. 93

- Administration: The main reception is where visitors arrive at the school. The arrival sequence is reported to be awkward between the staff as operations ensue during a normal day. The layout may be better served to be renovated, and operations flipped between the reception desk and the workroom/conference room. This could allow better flow and more convenient control when checking in visitors or adjusting attendance while keeping the desk open to help other students.

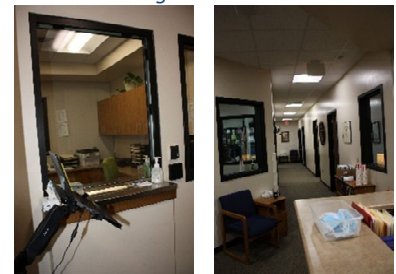
Figure Int. 94

Still located in the original admin and student services are the guidance offices and conference rooms, as well as other administrative offices. These spaces have adjusted in function but operate adequately. No concerns have been reported; however, there are opportunities that light renovations will upgrade the functionality.

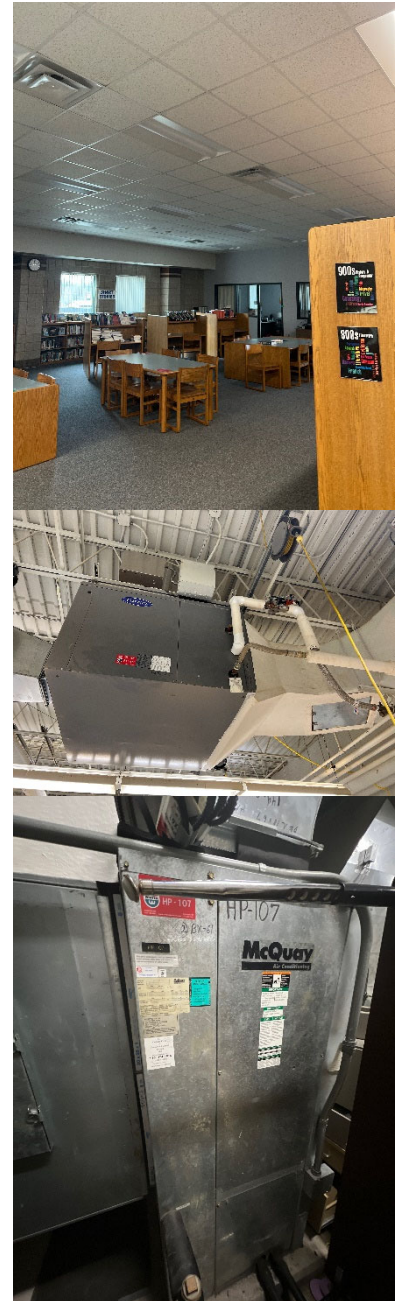
- All areas of the school are served with overhead air distribution from the packaged water-source heat pumps and fan coil units. The heat pumps typically serve either one of a couple of rooms and provide conditioned air to the space based on space requirements. The units can slightly vary airflow and air temperature supplied to the space(s) to maintain temperature setpoints.

- Replace the water source heat pumps that have extended past their service life with either new units or evaluate a different system type if the facilities group has a different preference.

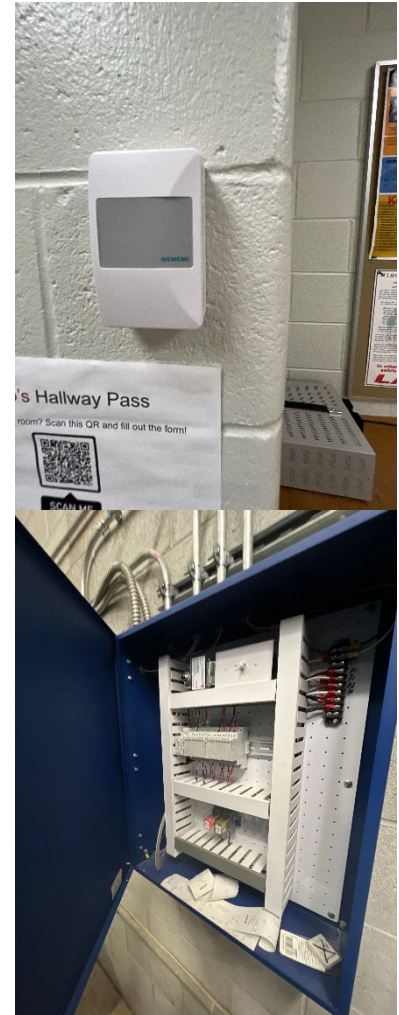
- The building controls systems are DDC with Siemens automation system (BAS) interface. This system is comprehensive over all major HVAC equipment with zone/space controllers. The BAS appears to have the ability to fully control, trend, alarm, and notify the Customer of needs and inconsistencies in the system.

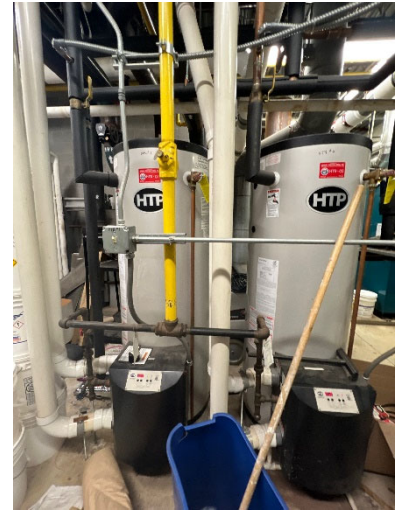
- The building is served by two high-efficiency gas-fired water heaters and recirculation pumps. These units are in fair condition.

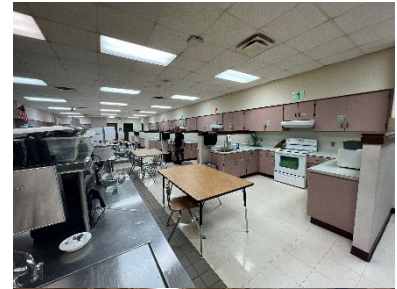
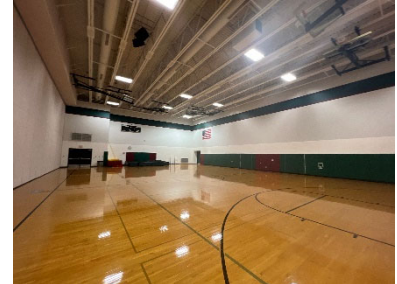
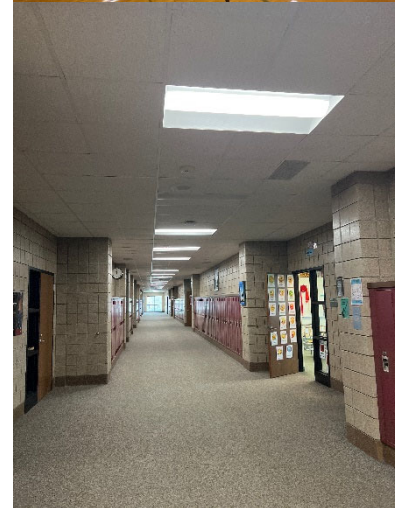
- All of the interior lighting appears to be LED fixtures that illuminate the space learning environment. Most of the spaces were observed to have adequate light levels.
