Clay Lamberton Elementary School

Building Overview:

Existing Condition Assessment:

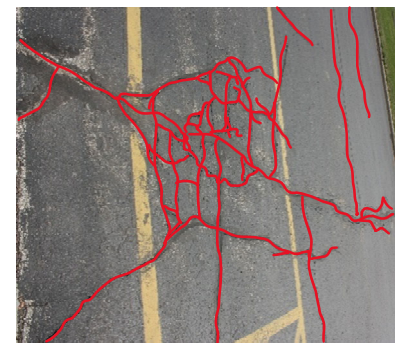
Figure Ext. 2

Some sections of the concrete sidewalk are significantly cracked (Figure Ext.2). These sections, if done properly, can be replaced separately, but full contiguous replacement provides a better solution with a longer life cycle.

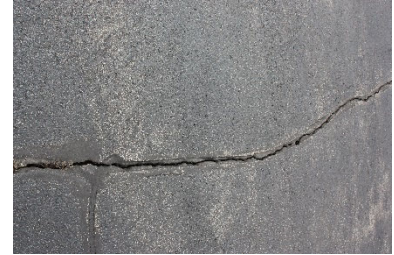
Figure Ext. 6

Note the curb deterioration at the north exit stoop in Figure Ext.6 is an additional concern contributing to the deterioration of the asphalt.

The Service drive on the north side of the building is in poor condition in several locations (Figure Ext.5 & Ext. 6). The cracks allow water to infiltrate the substrate. In this climate, the water freezes and heaves the asphalt making more cracks. The cold seams between section installations usually are the first cracks to form. One of the concerns with the extent of the north drive isle condition is that the asphalt will begin to dislodge, and the students running out to the playground surfaces will trip on potholes or loose pieces of asphalt.

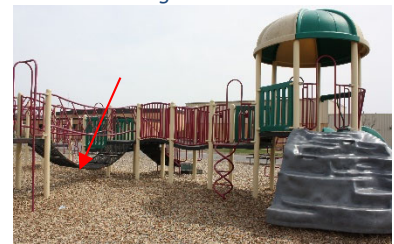
Figure Ext. 8

- **Play Areas and Structures:** The play structures are in fair condition but are showing significant wear (Figure Ext.8 – Ext.10). These structures are dated, and many of the features are not particularly utilized by most of the students.

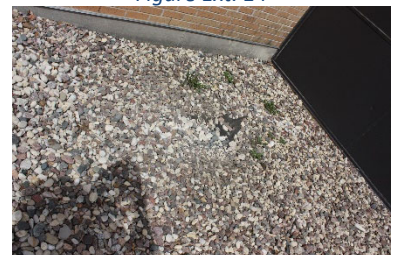
Figure Ext. 15

This condition occurs extensively along the edge of the building, as seen in Figure Ext.15, where the asphalt is sinking (Figure Ext.15).

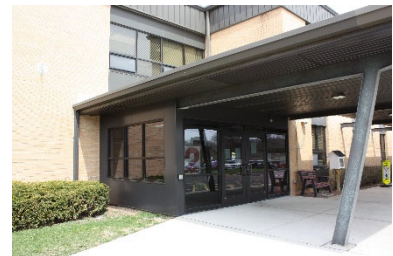
Figure Ext. 18

A little rust is forming at the base of the metal frame at the door's hinges (Figure Ext.18). The rust will need to be mitigated before it progresses to keep the rust from spreading and to increase the lifespan of the door assembly.

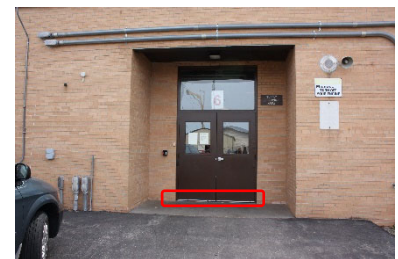
Figure Ext. 24

- Exit/Entrance 5: This hollow metal door has double full-lite leaves and is in good condition. Electronic card reader access is installed on this door as it is adjacent to the staff parking lot. There is rust at the bottom of the door frame that needs attention to arrest the progression of rust (Figure Ext.24). The sealant at the frame perimeter is intact and functioning. The canopy here helps protect the opening from the elements.

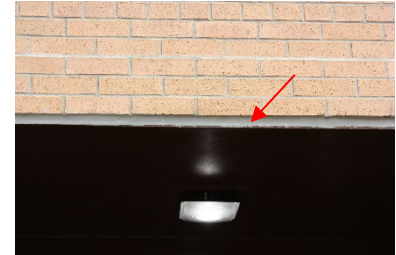
Figure Ext. 26

- Exit/Entrance 7: This door accesses the school through a vestibule and is adjacent to the kitchen. Additionally, there is a direct exterior access door to the kitchen on an adjacent wall (Figure Ext.26).

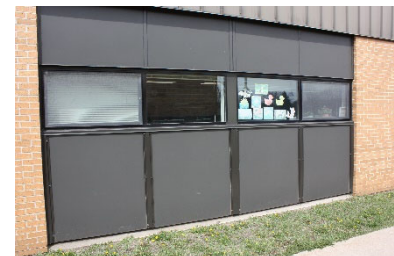
Figure Ext. 37

Another location with similar windows in the original building has brick above and below the window assembly (Figure Ext.37).

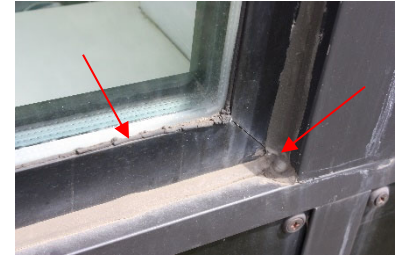
Figure Ext. 39

At the head of some of the window's calk has been installed at the flashing (Figure Ext.39). This may have been intended to mitigate some water

infiltration; however, the flashing at this location usually is the weep relief for the panel assembly.

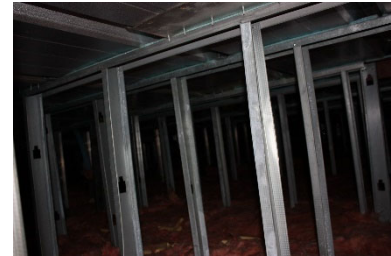
Figure Ext. 73

- Roof Over-Framing:** As mentioned previously, the original school roofs were over-framed to deploy a standing seam metal roof as installed on the 1989 and 1991 additions to the building. The roof over the main portion of the first floor has an inverted slope with a built-in gutter in the center. Whereas the two-story portion has a traditional gable slope to the framing. There is a degree of ventilation required for this installation. The other apparent concern is the installed batt insulation above the original roof. If the insulation gets wet from a roof leak, there is a potential for mold cultivation if the moisture does not get removed by the installed ventilation. Further evaluation is recommended to verify the installed ventilation is adequate.

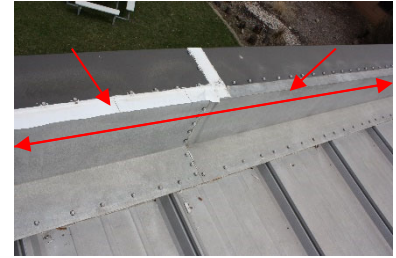
Figure Ext. 77

Most of the flashing on the metal roof cover on the over-framed portion has a termination bar condition with sealant at the top of the bar (Figure Ext.77).

- **Roofing:** The installed sealants on the standing seam metal roofs need to be fully inspected to verify their integrity. The exposed fasteners also should be inspected to verify the gasket or washers are still actively sealing around the fasteners. A future capital improvement project could be the replacement of the roof system to include a sheathing to provide more stability to the roof system.

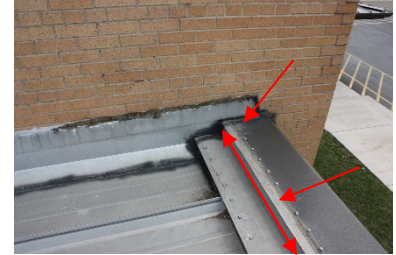
Figure Ext. 78

- **Parapet Copings:** the largest concern with the coping installations on the metal roof conditions is the exposed fasteners on the top of the copings (Figures Ext. 78, Ext. 79, & Ext. 80). Several different preventative measures have been installed to combat leaking at these coping caps.

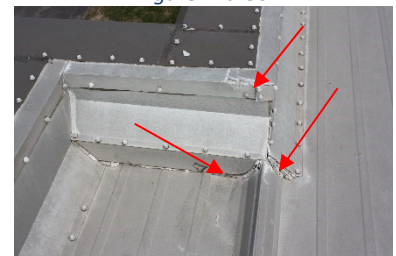
Figure Ext. 81

The vertical end flashings at the high ends of the sloped are coped over the seams and ribs (Figure Ext.81). Some of the sealant at these locations is a blind condition behind the flashing. It appears some of these are drying out. The sealant in other similar locations that have been applied after the original installation is also drying out and cracking (Figure ext. 82). This sealant is brittle. It will eventually fall out or off, creating an open gap. The high point portions of the roof have a smaller likelihood of leaking than the low points; however, wind-driven rain can penetrate these conditions.

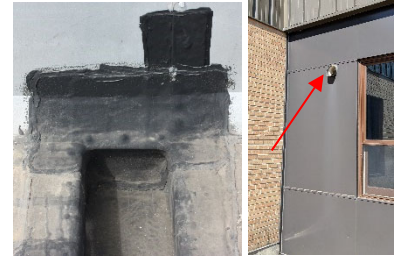
Figure Ext. 84

- **Roof Drainage Components:** As mentioned before, the lower roof on the original elementary building has an inverted slope that drains everything to a central building in a gutter (Figures Ext. 83, Ext.84, & Ext.85). This gutter system was connected to the vertical conductors at the original roof drains or overflow system.

- Drainage Components:** The external gutters and downspouts do not need immediate maintenance. Consider altering the downspout on the roof where the outfall is split around a roofing seam. The built-in gutter systems have a more critical concern. If this leaks, it can cause more issues and be harder to detect as they are in the attic spaces. These need to be inspected more often. If these reroofing systems are ever replaced, it is recommended to reconfigure these to not be built in.

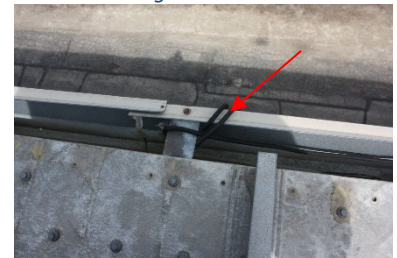
Figure Ext. 86

At the lamb's tongue outlet (Figure Ext.86), located at the southwest corner of the original building, A steady volume of water is discharged

here during rain events. This indicates the integrated gutter is connected to this outlet, and the attributing area for this discharge is the first-floor section of the original building. As mentioned before in the site drainage portion of this report (Figure Ext.16), the force at which the stormwater exits this discharge point hits the river rock in the landscaping bed at a velocity great enough to displace the stones.

Gutters are deployed at the metal roofing installations (Figures Ext. 86 & Ext.87). Most of the conductor's discharge via downspouts is discussed later in this report.

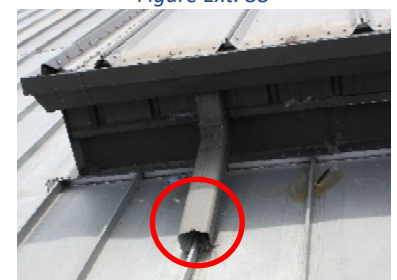
Figure Ext. 89

There are a few locations where downspouts discharge onto the metal roof below (Figures Ext.89 & Ext.90). There are no logistical concerns with these discharge points as long as the final gutters and conductors can adequately handle the stormwater volumes. Further analysis may be recommended if verification is desirable.

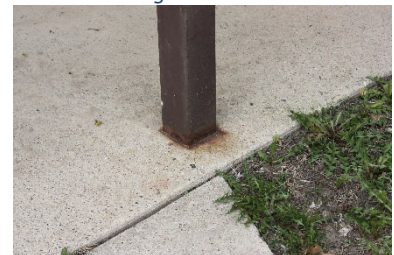
Figure Ext. 99

Other canopies that have a square tube steel column (Figure Ext.99) have the base plate concealed below the sidewalk. The bottom of this column is also rusted.

- **Canopy Assemblies:** The rust should be mechanically removed with wire brushes and the steel primed and repainted to arrest the progression of the rusting. Consider lighting cleaning the brick masonry faces under the beam connection to the wall.

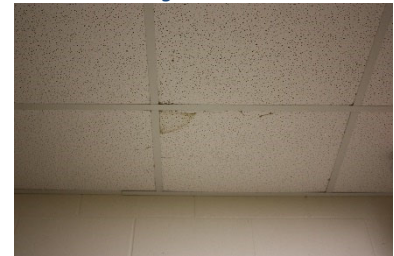
Figure Int. 2

There are some locations observed to have staining on the ceiling tile surface, indicating it had been wet at some point in time (Figures Int. 2 & Int. 4). This could be from a roof leak or a leak in a piece of mechanical equipment. It does not necessarily mean there is an active leak, only that a leak had occurred and may have already been rectified. These conditions should be investigated to verify that there are no active leaks.

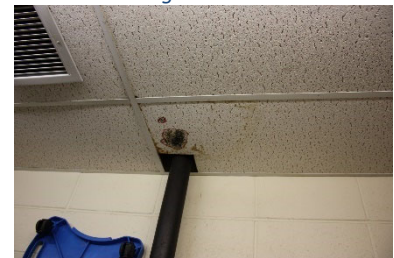
Figure Int. 4

Where darker stains are present near penetrations (Figure Int.4), it is a bigger concern to remove the tile and replace as well as verify that no active leak is present.

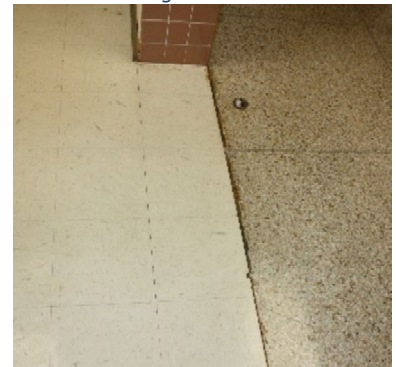
Good locations for control joints are between major building transitions or planned changes in the flooring. Figure Int. 8 the change in flooring.

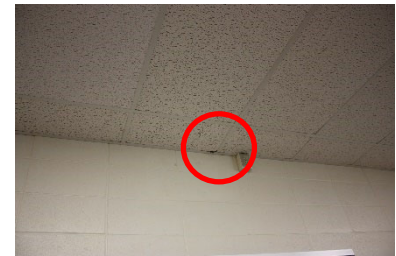
Figure Int. 20

- Classroom Ceilings: The ceilings in the classrooms are typically 2x4 ceiling tiles (Figure Int.20). Like the corridors, the oldest portions of the building have some tiles that are sagging in the middle, and there are tiles with damage and stains (Figure Int.20).

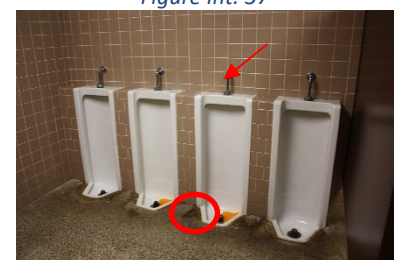
Figure Int. 38

The urinals are floor mounted and, in some cases, have a gang flush function, likely on a timer (Figure Int.38). This is another example of where water waste can be improved upon.

The floor around the urinals is a very stained terrazzo.

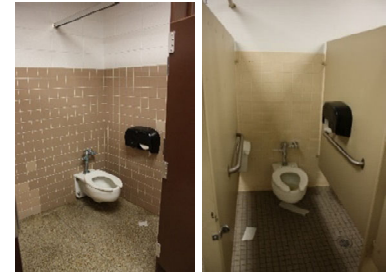
Figure Int. 40

There are some Full ADA-compliant toilet stalls (Figure Int.40), but most of the facilities only have ambulatory stalls available (Figure Int.41). This is quite typical of older buildings.

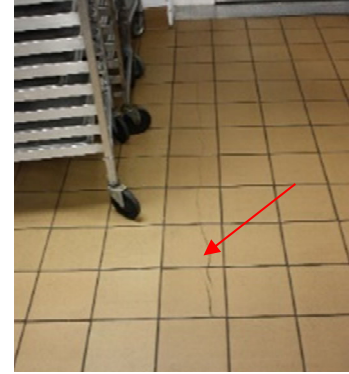
Figure Int. 47

The floor is a quarry tile floor that is very common in school kitchens of this vintage. There is a crack through the tile in one location on the floor (Figure Int.47).

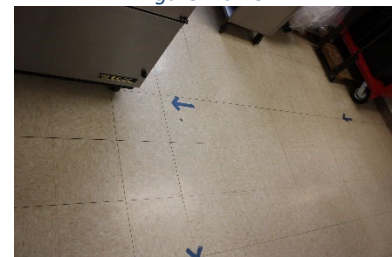
Figure Int. 50

Tape arrows are placed on the VCT flooring for traffic direction (Figure Int.50). This could potentially be a permanent strip added before refinishing.

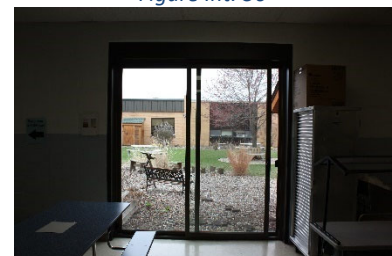
Figure Int. 51

There is a sliding patio door located in the cafeteria, which is the only access from inside the building that leads to the courtyard. The threshold is not ADA Compliant, so a wheelchair-bound individual would need to access the courtyard from the exterior fence gate. The sliding door is not used as the courtyard is reportedly not used very much. The door is opened to allow the natural venting of warm air from the space.

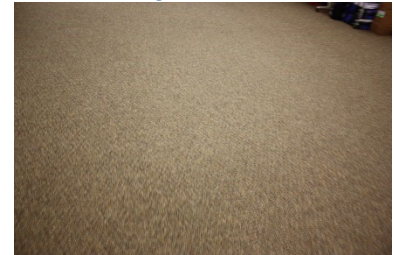
Figure Int. 53

The space has sheet carpeting in good condition; however, if a tear or stain should occur, the entire floor will need replacing. Carpet tile would prevent this requirement upon damage discovery.

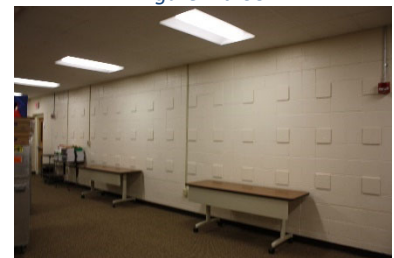
Figure Int. 54

The walls are CMU with protruding block patterns to assist in acoustical quality. They help a little, but the room seems a little more live than it should be.

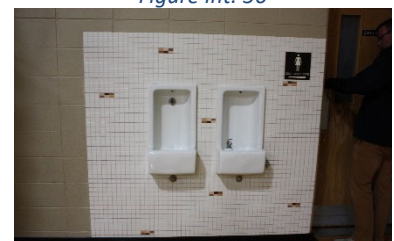
Figure Int. 57

Some are flush mounted, and some are also recessed into the wall (Figure Int.57). the older drinking fountains do not have a touchless bottle filler associated with them.

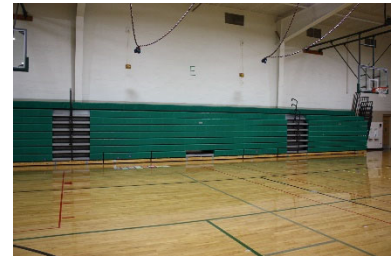
Figure Int. 61

- Gymnasium: The gymnasium flooring is natural wood in pretty good condition (Figure Int.61) with a few scratches and scuffs. The bleachers have been replaced with telescoping bleachers containing accessible spectator capabilities.

- Gymnasium: No immediate concerns are recommended currently.

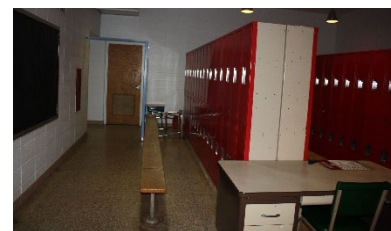
Figure Int. 64

- Locker rooms: There are newer lockers in the boy's locker room (Figure Int.64) but not in the girl's locker room (Figure Int.65). The original wood benches are still in both locker rooms, and the finish is very worn.

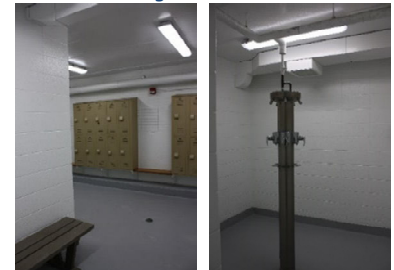
Figure Int. 66

In the changing/locker rooms of the pool, there are two-tier units and much fewer of them (Figure Int.66). The floor covering in the pool changing area and the rinse-off station is an epoxy coating (Figure Int.67). The wood benched also need to be refinished.

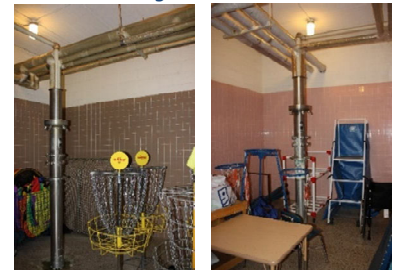
Figure Int. 67

The gang showers in the locker room are not utilized as they have gym equipment stored in them (Figure Int.67). It is becoming common that students do not shower after the gym class is concluded, even if they change clothing for class. This typically comes down to a privacy issue.

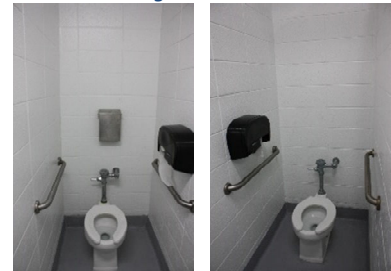
Figure Int. 75

The restrooms in the pool changing area are only equipped with ambulatory toilet stalls (Figure Int.75).

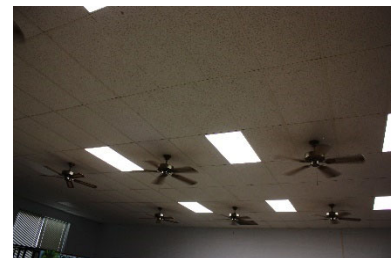
Figure Int. 76

- Music Room:** The music room is a large, uncooled space. There are nine ceiling fans installed to help provide comfort in the classroom (Figure Int.76). The ceiling is a 2x4 acoustical ceiling tile, and the walls are hard CMU. There are no significant acoustical treatments on the walls to assist with acoustical control. There is casework used for storage; however, there is loose storage at the back of the room. There is a horizontal crack at the lintel line of the windows (Figure Int.77). There may not be a structural concern; however, evaluation is recommended.

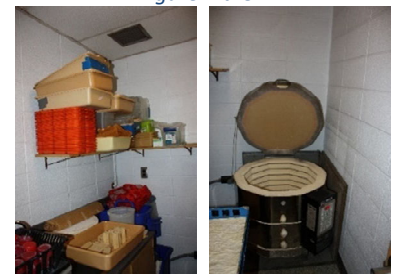
Figure Int. 82

The kiln is in a small room with additional storage (Figure Int.82). It may be necessary to minimize the amount and type of items located in this space.

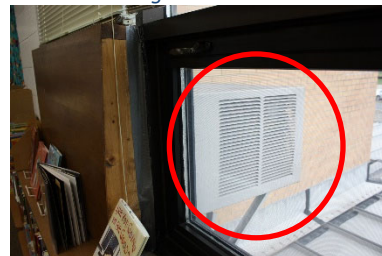
Figure Int. 86

There is no cooling integrated into the building in this area. Small window air conditioning units are installed in the media center (Figure Int.86). These units likely struggle to keep the space comfortable. This is not a viable long-term solution to the need for cooling.

- Media Center: Consider replacing the carpet with a carpet tile for a more resilient and lower maintenance installation. Refer to the mechanical analysis portion of this report for recommendations on cooling.

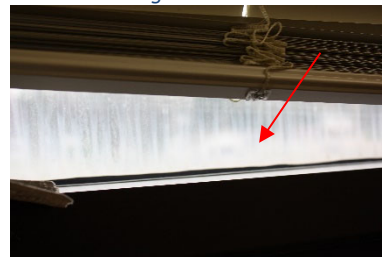
Figure Int. 87

There is discoloration between the glazing panes on some of the windows (Figure Int. 87). This indicates the gaskets and seals for the double pane glazing units have failed and are no longer preventing heat transfer as condensation is occurring between the glass.

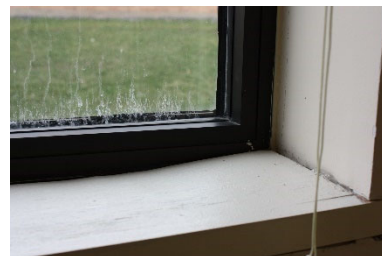
- **STEM Lab:** the new STEM lab location also has failed glazing and evidence of leaking at the window frame (Figure Int.88). the plastic laminate sill in Figure Int. 88 is severely damaged and delaminating. The cause of the water intrusion may have been rectified with the recent envelope repairs, but the damage to the interior will need to be addressed next.

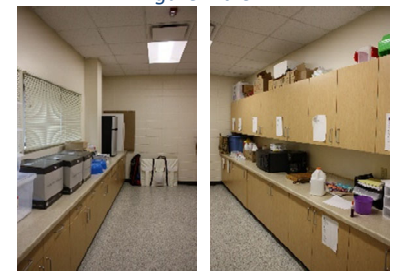
Figure Int. 93

The STEM lab is also inheriting a prep area with direct access to the lab (Figure Int. 93). This will be helpful for the instructor to secure more sensitive materials to control use for safety.

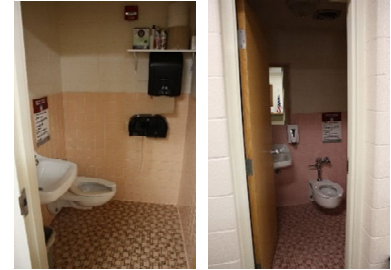
Figure Int. 95

The staff restrooms are outdated and do not meet the current accessibility code. The faucet and flush controls are manual; however, since adults typically utilize these fixtures, there is less of a concern for having them left on or unflushed. There would still be an advantage to using touchless controls for reducing water usage and control of bacterial and viral spread.

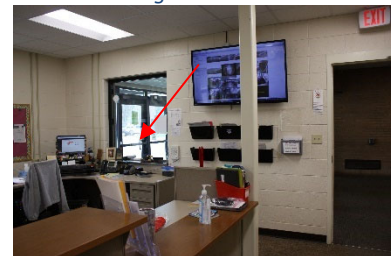
Figure Int. 98

The reception area also serves as a secure check-in (Figure Int.98). The staff checks-in visitors in the entry vestibule. Visitors can walk into the school first into the vestibule without the staff first buzzing them in as the first point of challenge. The exterior outside the vestibule is protected from the weather with a canopy. A better condition would be to have a video phone system outside the locked vestibule for the first point of challenge and keep the additional locked door to the school as a second challenge door for post-check-in. Additionally, seating can be deployed in the vestibule if a visitor needs to wait for an escort.

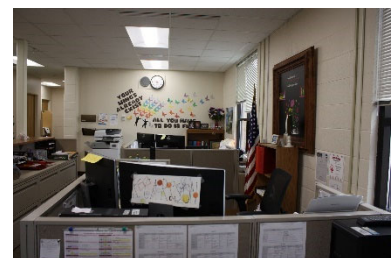
Figure Int. 99

The main office reception area has workstations not adjacent to the security window (Figure Int.99). It is also reported that only one staff workstation has the ability to buzz-in visitors.

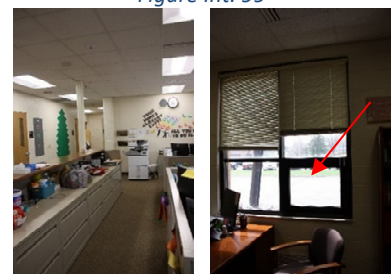
Figure Int. 100

The security window has ballistic safety glazing, but there is some concern that the windows adjacent to the public approach to the school are not protected by a ballistic film (Figure Int.100). The staff workstations are orientated to the side or in front of the windows as they need visual control of the office putting their backs uncomfortably facing the windows.

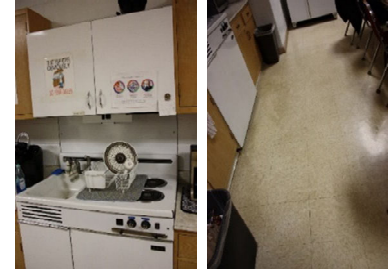
Figure Int. 101

The faculty break area is outdated with original cabinets, range, and dishwasher (Figures Int.101 & Int.102). The flooring is older Vinyl composite tile and appears to be original. The tile or the mastic for this flooring may be an ACM (Asbestos Containing Material). This is only an issue if planned renovations are to occur.

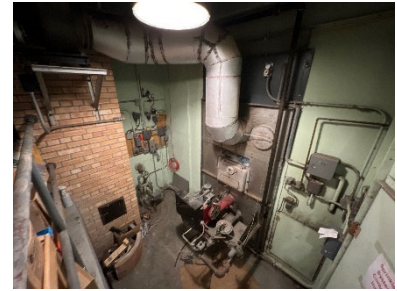
- All areas of the school are served with overhead air distribution from the packaged RTUs, AHUs, and fan coil units. The RTUs and AHUs typically serve multiple spaces. Some units may have variable air volume (VAV) boxes, but most are multi-zone type units that should be replaced. The VAV boxes vary airflow and air temperature supplied to the space(s) to maintain temperature setpoints.

- Replace the multi-zone AHUs with new AHUs that utilize VAV terminal units (VAVs) and new distribution air ductwork to increase thermal comfort and energy efficiency.
- Replace/refurbish the kitchen hood and/or exhaust fan serving the kitchen hood.

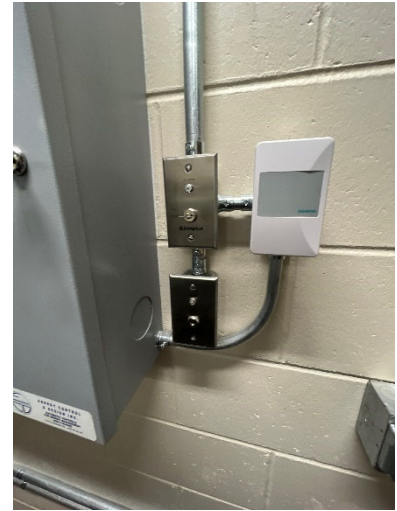
- The building controls systems are a mix of pneumatic controls with/and without DDC transducers, DDC Siemens (BAS) interface, and what appears to be standalone controls. This system is not comprehensive over all major HVAC equipment with zone/space controllers. The BAS appears to have some ability to fully control, trend, alarm, and notify the Customer of needs and inconsistencies in the system, and existing and new systems should be fully integrated into the BAS.

- Upgrade needed HVAC systems and integrate new controls into the BAS.

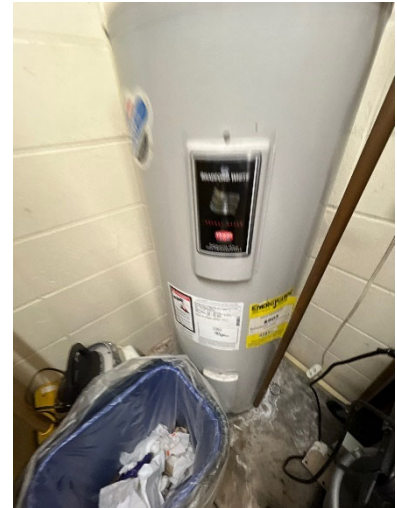
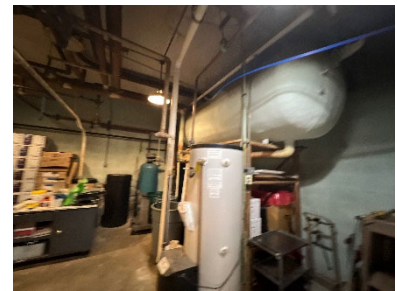
- The building is served by two standard-efficiency gas-fired water heaters and recirculation pumps. These units are in good condition.

- No recommendations currently.

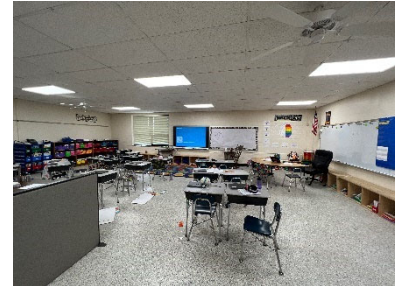
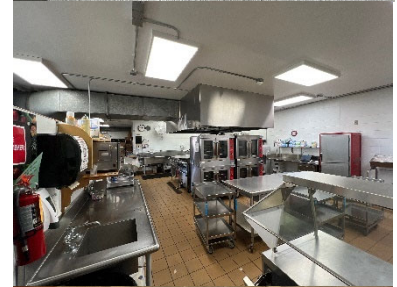
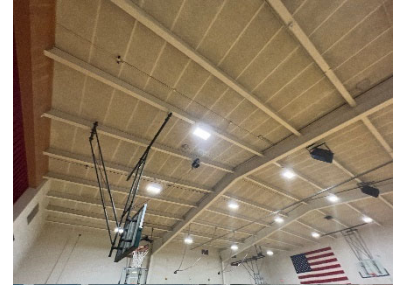
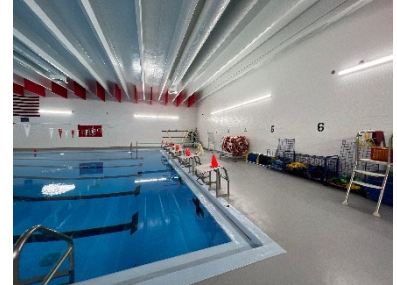
- All of the interior lighting appears to be LED fixtures that illuminate the space learning environment. Most of the spaces were observed to have adequate light levels.

- No recommendations currently.
